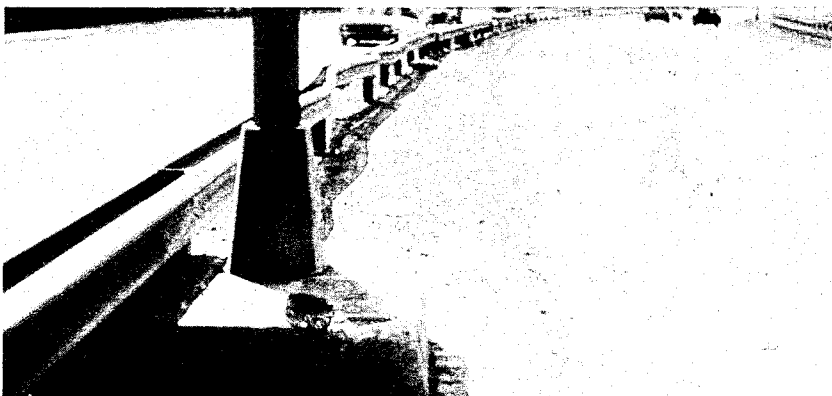
Here you see another light base which is a hazard. It is right in the shoulder area. It has been chopping up the cars for years and nobody wants to do anything about it. It is hard to see, but that edge is chipped off and as the cars ride this particular guardrail, they just knock down this pole anyway, even though the base is there, and they chop up their cars unnecessarily.
