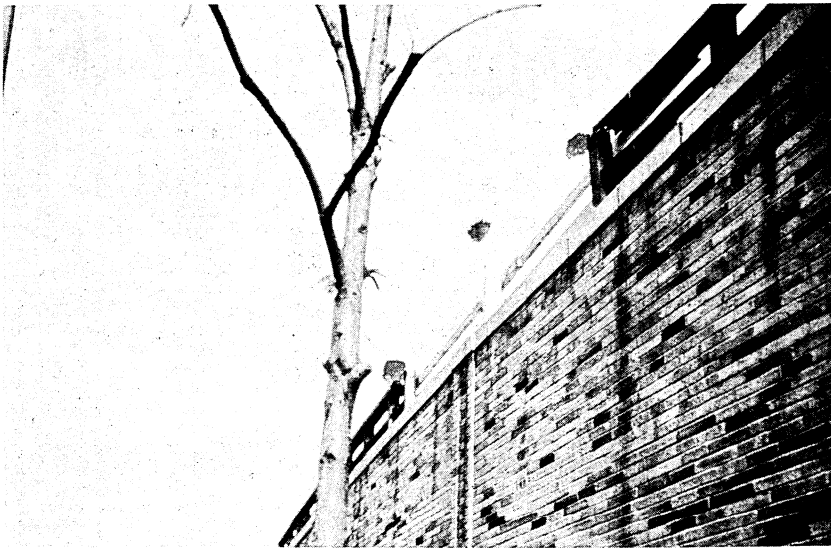
Here you see another place where somebody ran right through. You can look at the tree branches that broke off. I feel they made a serious mistake using this type of material on an Interstate highway. If cars can go through, so can trucks and buses, and you can have a disaster.

I feel we have an obligation and go back and strengthen these points as soon as possible before a gasoline truck or something goes through these railings.

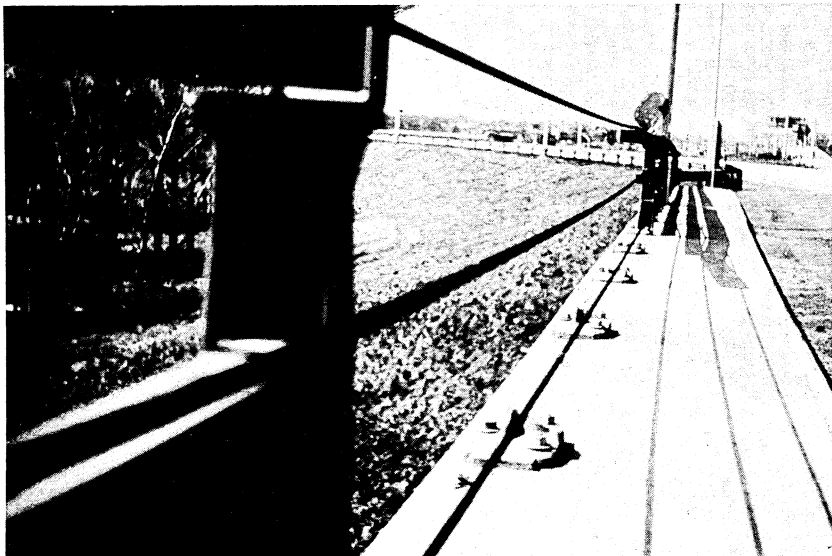
This is another aluminum installation. You can see it just snaps right off.
