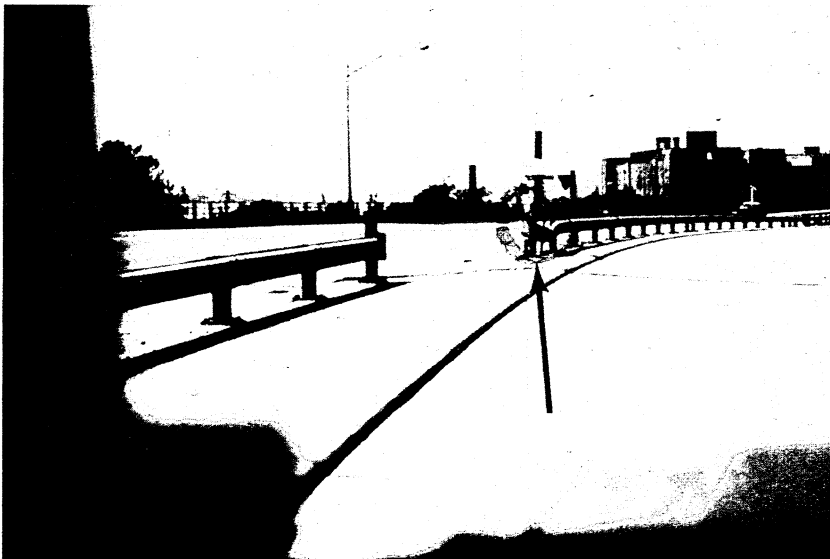
Here you can slide along there and it is impossible to hit the end of the opposite rail. They could have done the same thing at the other location, but no one was thinking.

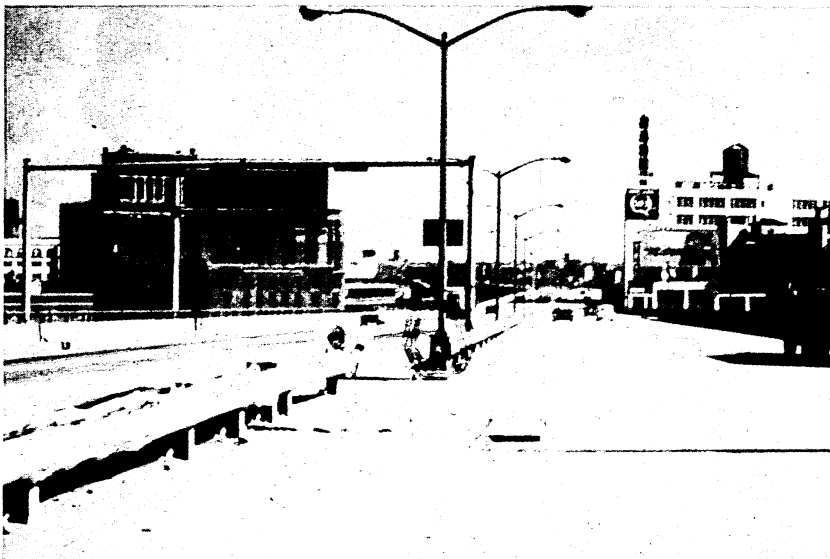
Most of our highways are in this condition. You leave the road, slide along the guardrail, and you have run into the end of the next section of guardrail.

And this has been hit; sort of standard practice on highways in our area.
