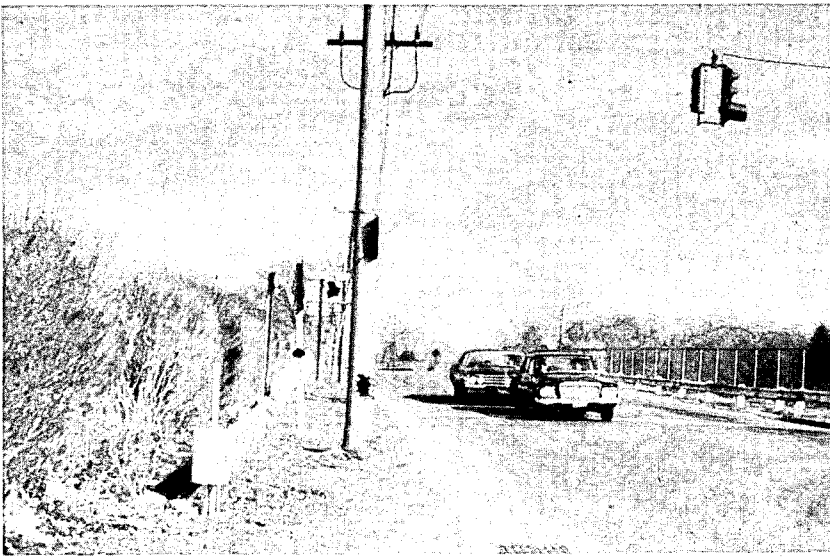
Now, this is a steel pole, 14 inches in diameter, that will split you in half. There is a guardrail on the left and there is a whole bunch of trees back further in the picture, but you barely see them. Every one of these is in front of the guardrail.

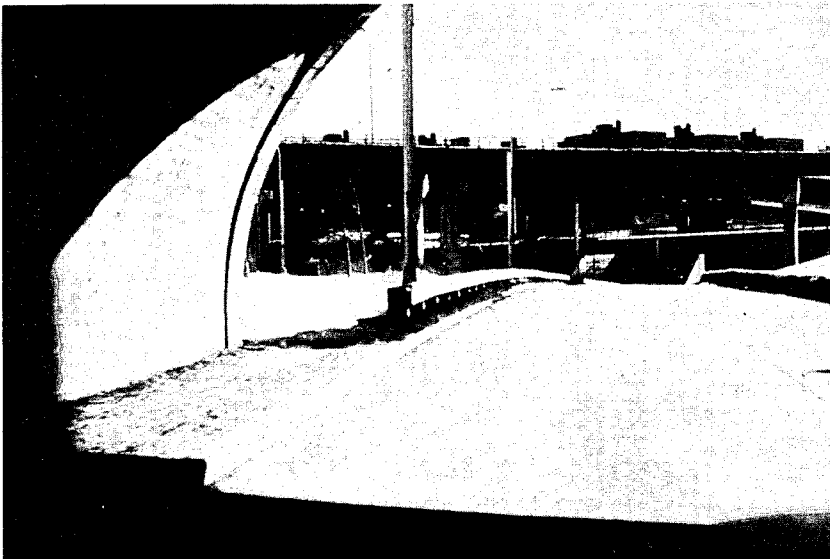
There must be something wrong when you see things like this on the highway, especially on new highways. All of these guardrails are installed wrong.
