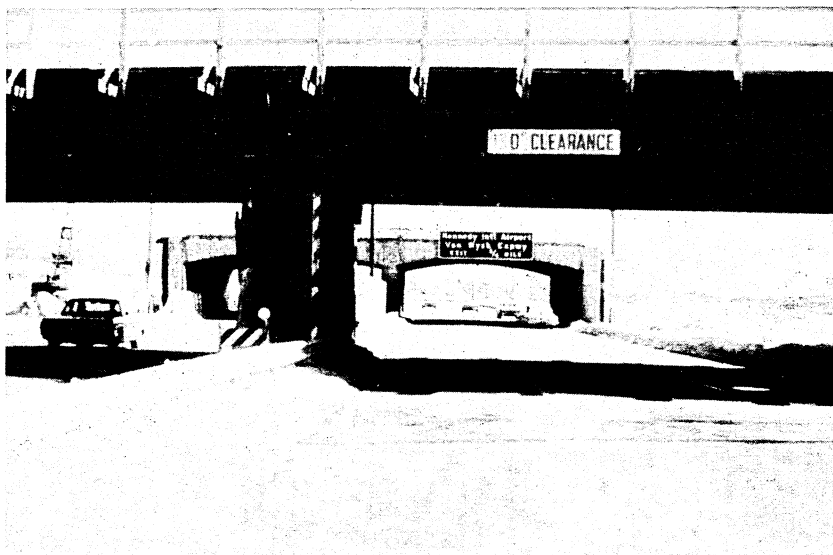
Here you see a job where they have a temporary overpass. The guardrail has been installed properly and a car can slide by this particular obstacle. This is good.

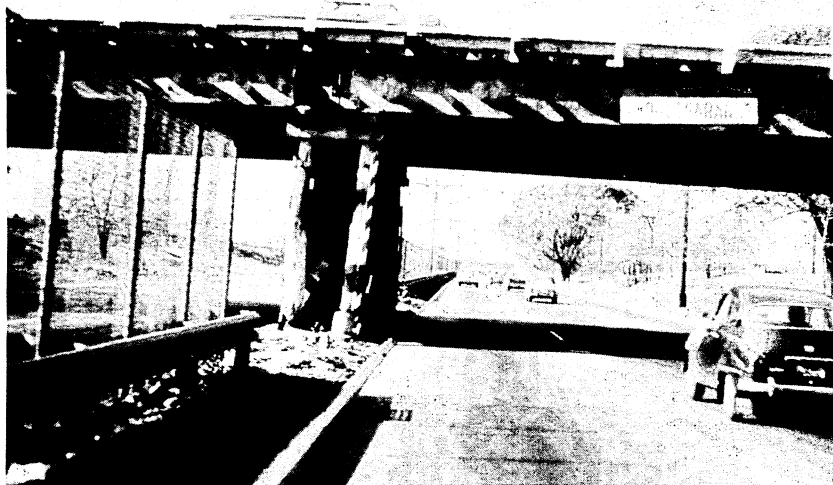
But others are not. Some of these stand like this for 2 or 3 months and provide no protection, they are hazards. There is more hazard now than before they started. They are not using this particular location, this area here; they leave it over the weekend. They should replace this guardrail here to give the motorist a break.
