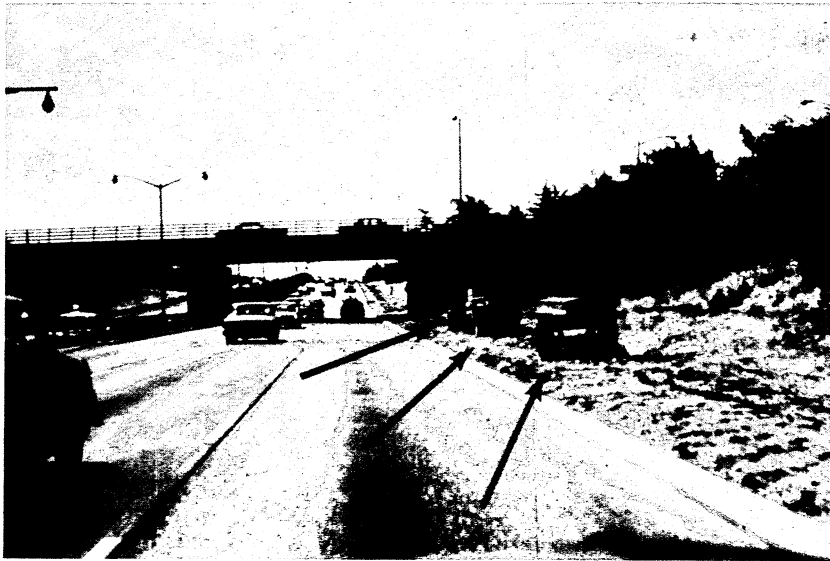
Here you have three separate pieces of equipment left on the road. The least they could do is put them all together. You would have one target. Here you have three separate targets. In fact, the right way is to take them up in front of the bridge abutment and put them behind there so you cannot hit them.

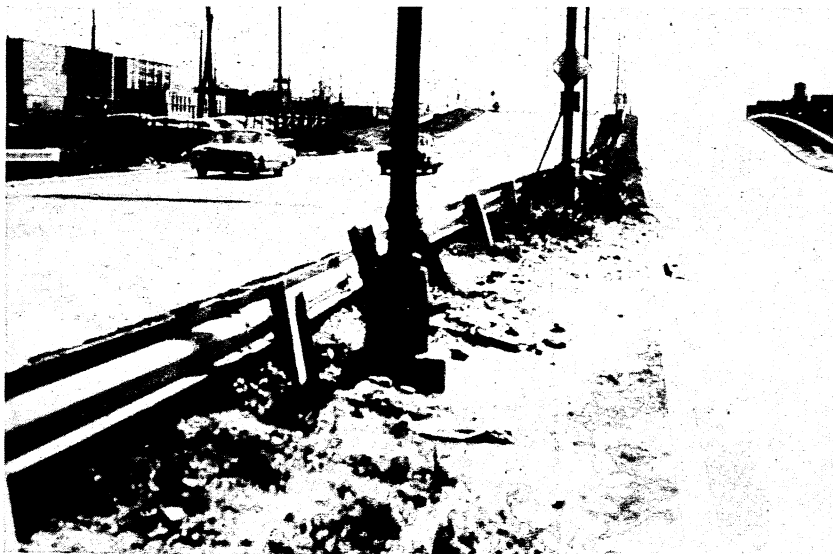
This guardrail is broken—has been for 2 years—and never replaced. Finally somebody came by and replaced it, but forgot to make a double rail and put the guardrail on this side for sliding action. The day they put it up somebody came by and wiped out the section there. They knocked down the light pole and ripped up the concrete abutment up farther. And it is the same way today, 4 months later.
