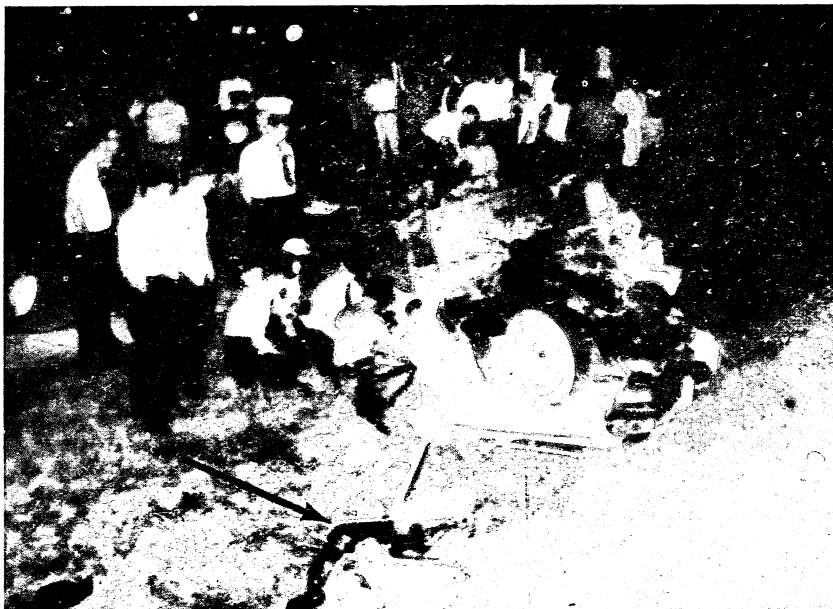
Mr. O'HARA. This vehicle hit a sign similar to the one we were just looking at. This accident occurred on Interstate Route 95, and I am showing this only for the purpose of letting you see what happens to a vehicle which hits one of these steel posts.

Mr. BLATNIK. Single-car-off-the-road type of accident, hitting the same type of steel post we just saw embedded in concrete?

Mr. O'HARA. That is correct. And in the lower portion of that photograph you can see the 50 number from the sign laying on the ground.

Mr. O'HARA. Right where the light is shining (indicating) you can see the 50.

Now, in this accident four people were killed and five were injured.
