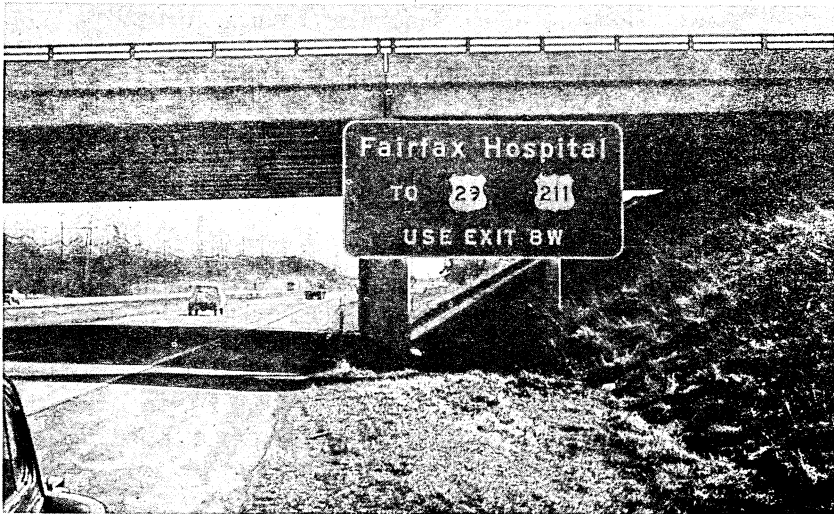
Here is another sign on the Virginia side of the Capital Beltway. Again, the sign is mounted on the steel post embedded in concrete; but this time it is up against the bridge. And neither the bridge piers nor the steel posts have a guardrail to shield a motorist who might run off the road and run into it.

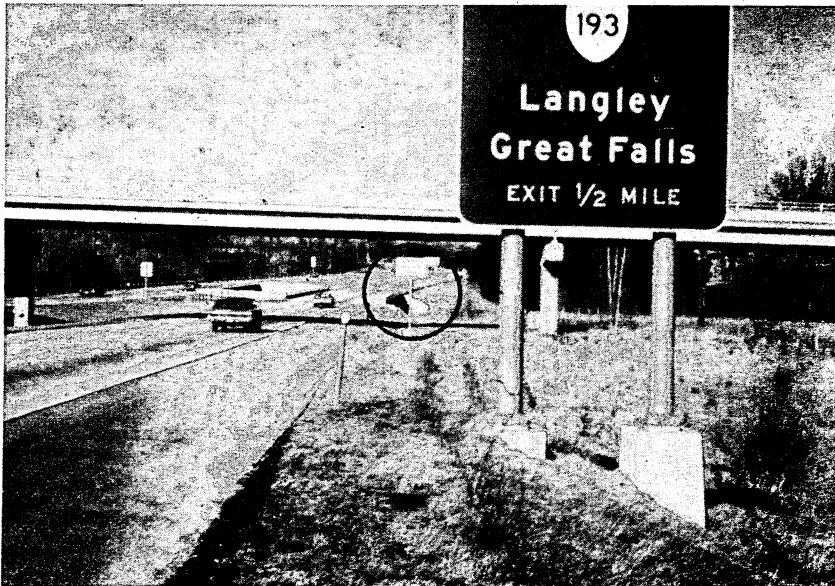
And here is another sign on the Virginia section of the Capital Beltway. I have shown this one to show you the amount of concrete which is above ground, especially on this right support.
