This is a bridge over the Capital Beltway. You are on the approach to the George Washington Parkway. The George Washington Parkway is up here [indicating]. These are the southbound lanes of the beltway from Maryland, crossing into Virginia, passing under this bridge.

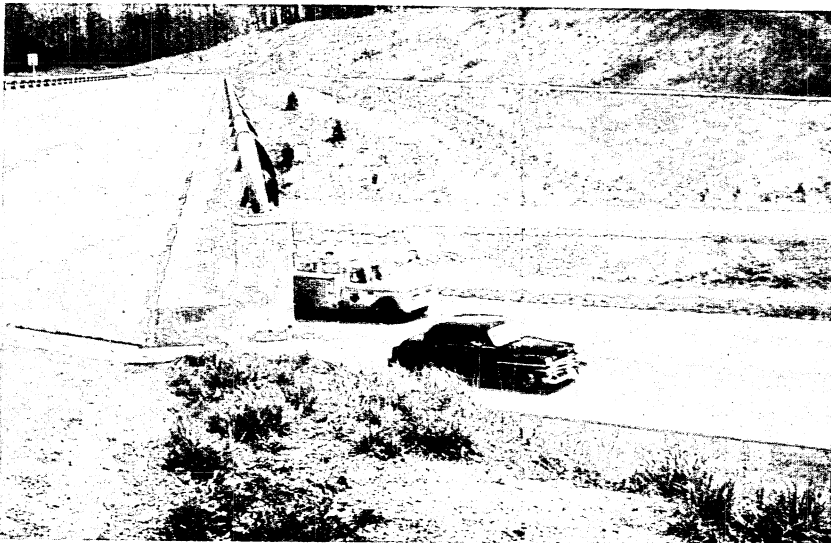
To orient you again, the Cabin John Bridge would be to your left. This photo looks toward Washington on the George Washington Parkway, and this is the approach. You will notice the bridge parapet. There is no guardrail here at this end and nothing to prevent a vehicle from getting down into this lane of traffic below.

The same situation exists on the far end of the bridge, and, in addition, we have a speed sign which says "Speed Limit 40 Miles Per Hour," mounted on a 4- to 6-inch steel post. And there is the same situation as regards the guardrail, there is none.

Mr. W. MAY. Mr. Prisk, there is no question that there should be a guardrail at this location.
