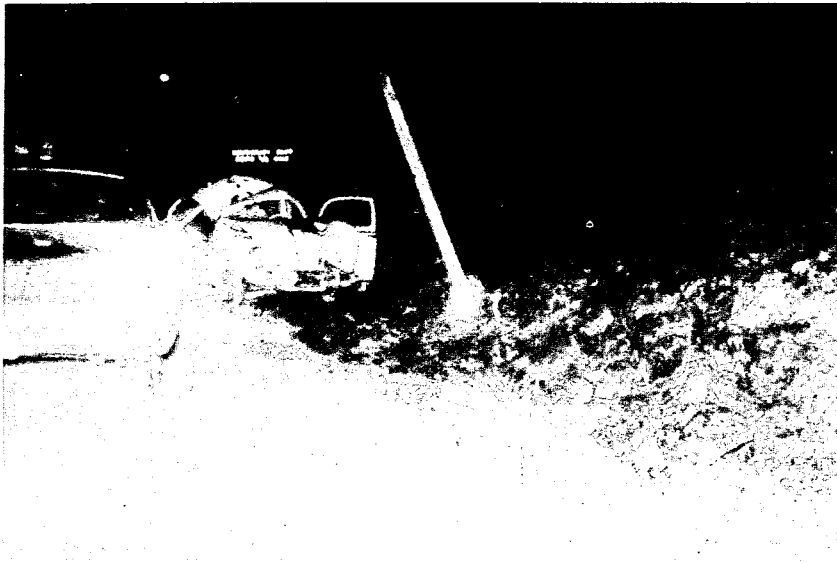
This vehicle ran off the road and hit that 4-inch I-beam. It took that 270 marker off the I-beam.
