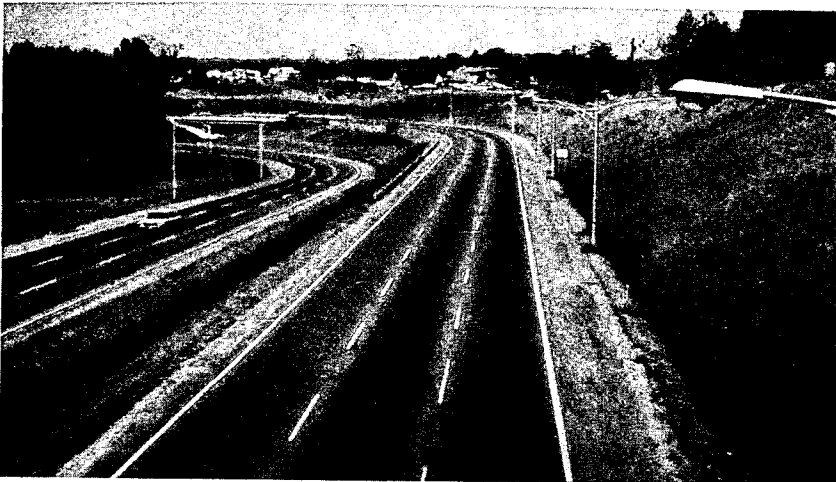
The next photograph was taken about where this light pole is [indicating] in the curve.

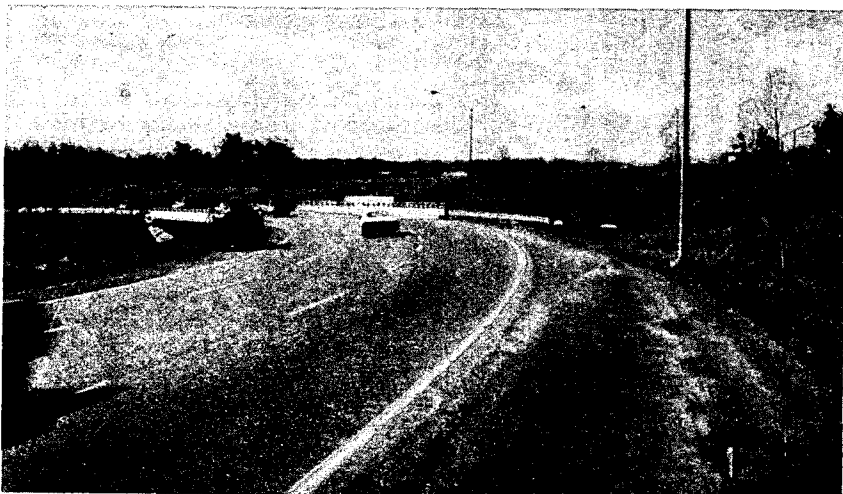
Last year, in this stretch around the curve, there were 24 accidents and four more occurred just beyond this curve in that short stretch to Bradley Boulevard.
