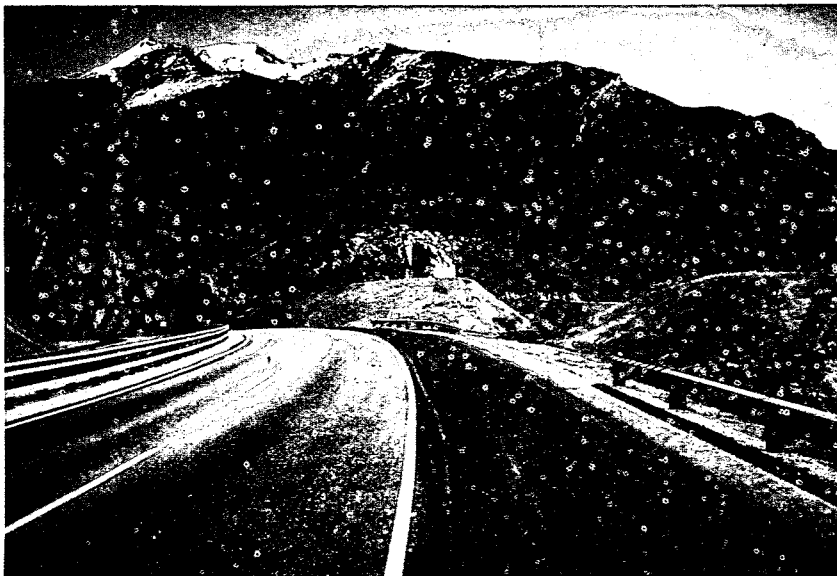
Here is another section where the rail runs for a way on the right-hand side, discontinues, and leaves you an opportunity up in this area to get, again, into pretty rough going.

Mr. CONSTANDY. That is quite a drop, incidentally. It doesn't appear so in that photograph, but it is very similar to others we have seen; you can go between the two sections of guardrail; if you went very far you would sail out into space. It is quite a drop.

Mr. PRISK. That is a very deep ravine.

Mr. PRISK. This is the slide with the deep ravine. There is a road right in here which apparently was used as a haul road by the contractor during the construction period, and now the highway patrol uses this in crossing from this roadway over to this one over here [indicating]. Otherwise, it is a long road to turnaround.

Mr. PRISK. It still is. You have an opportunity to impale on this post here. This gap we have seen.
