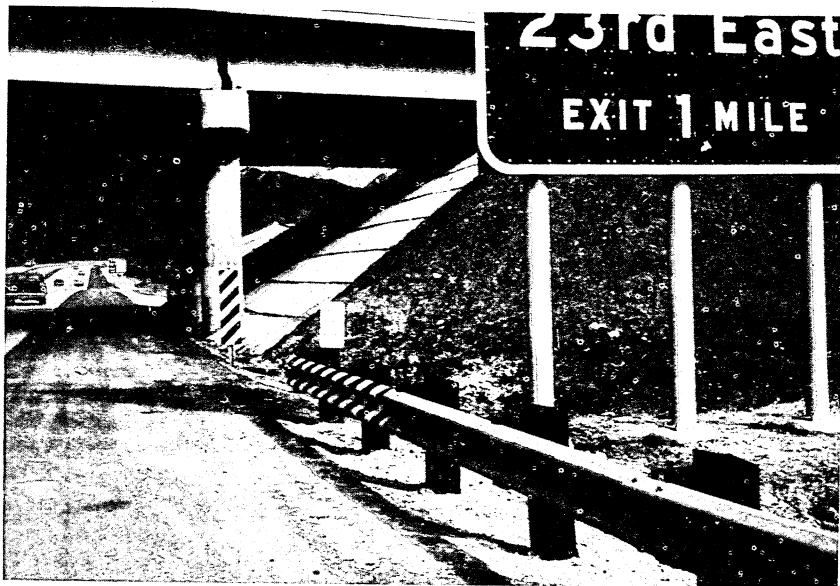
This again in the picture is a closeup showing about where the rail stands as far as these piers are concerned, and the sign post.

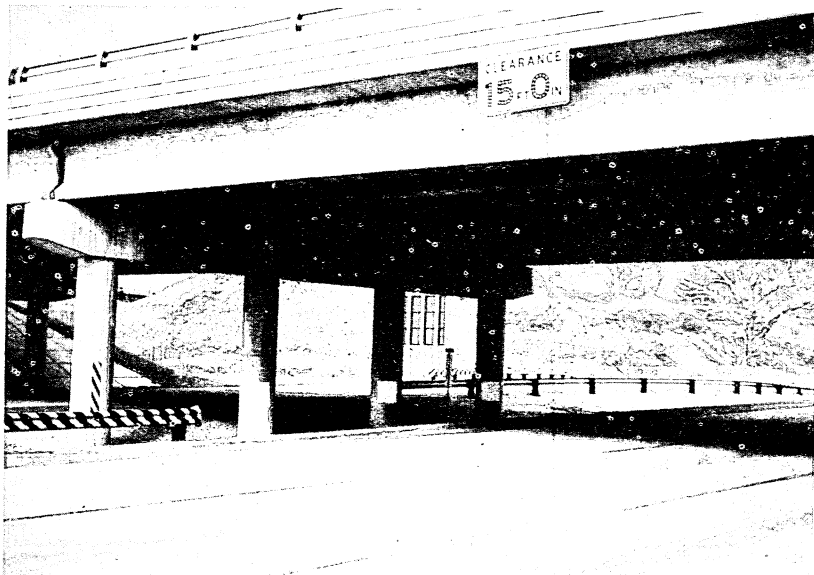
Here is a rail going partially through a structure on the median side and over on the far side for the opposite direction, the same kind of treatment and same kind of sign treatment as you see in the distance.

Mr. CONSTANDY. Of the four piers there, one of them is protected by the guardrail and the other three are exposed.

Mr. PRISK. That is true.
