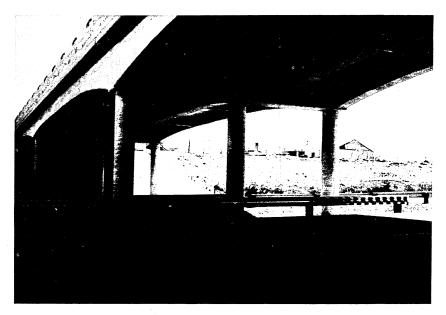
Here is a closeup running through the bridge on the median side. Now, here for some unexplainable reason you find that this guard-rail is buried in line at the very edge of the pavement and runs through the structure, but there is essentially no real protection for that angle of departure from the roadway insofar as that center pier is concerned.

Mr. Constandy. Just looking at it from another angle, they improved the length of the guardrail but we see it is still possible to go

behind it and strike the median piers.

Mr. Wilson. I do not know how the other members of the panel might feel but in this particular installation, I would rather see the rail nearer the center piers, not to the point where if they happen to bend over slightly, they would hit those piers, but I think giving extra maneuvering room to traffic is extremely important here, and I would move that over about 10 feet.

Mr. Constandy. That is from the left shoulder closer to the median piers.
