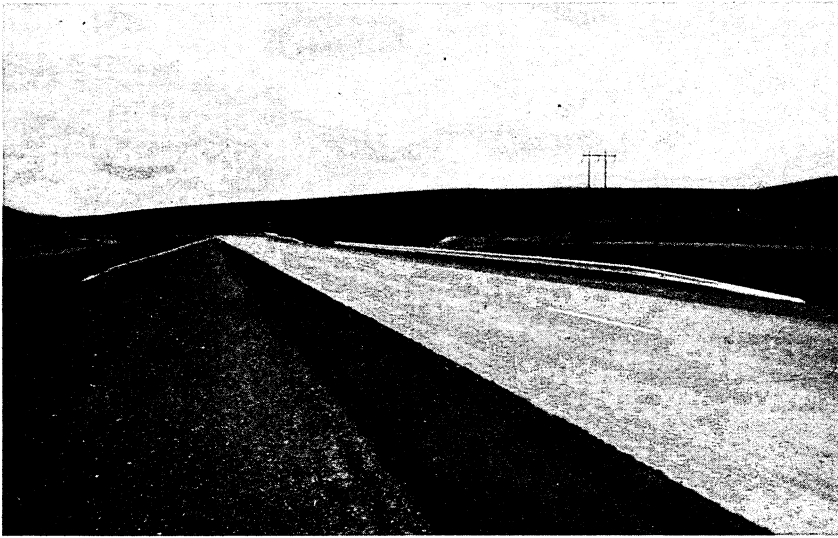
We move along on this section. This is about the way it looks as those portions are completed. The rail is taken down a slope, both in the median and on the right-hand side.

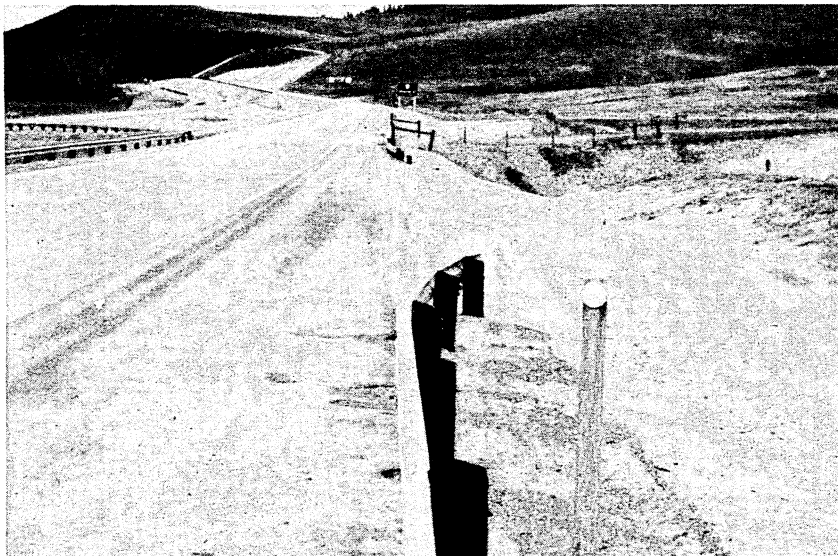
Here is a case where you have a gap and somebody put the flare in on the wrong end, because you are driving in the same direction as the camera is looking and there is a nice waterhole straight ahead, if you follow that flare, that you could drop into, up in this general area here [indicating].
