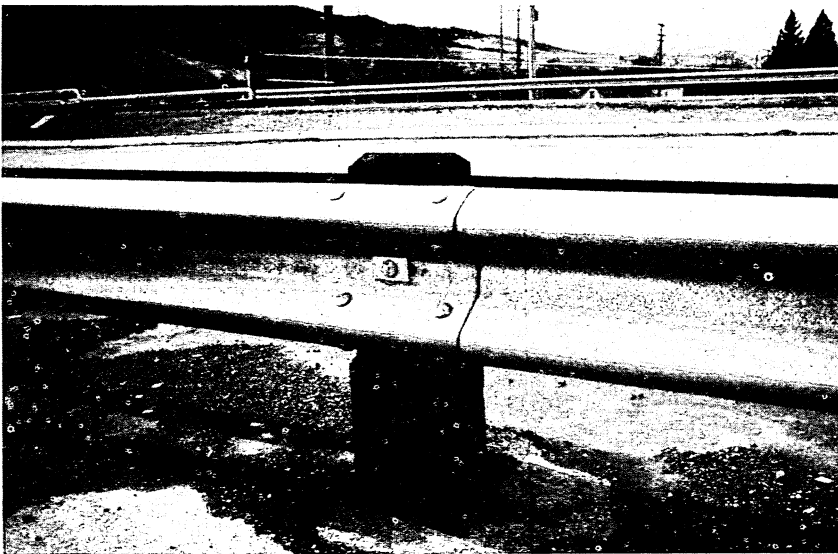
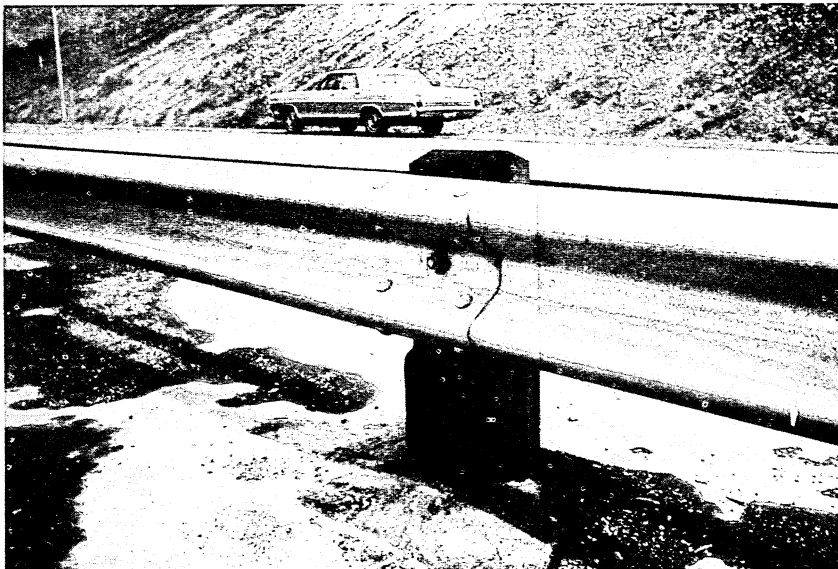
The sections in Montana have something to recommend them because here is the appearance of a washer clearly on a median barrier and this is back in the urban portion, near Missoula, and in this case the rail is not only not blocked out, but the rail is notched into a wooden post. There is an 8-by-8-inch wood post there and the post actually has been notched so it is down to about 5 inches thick at the top.
