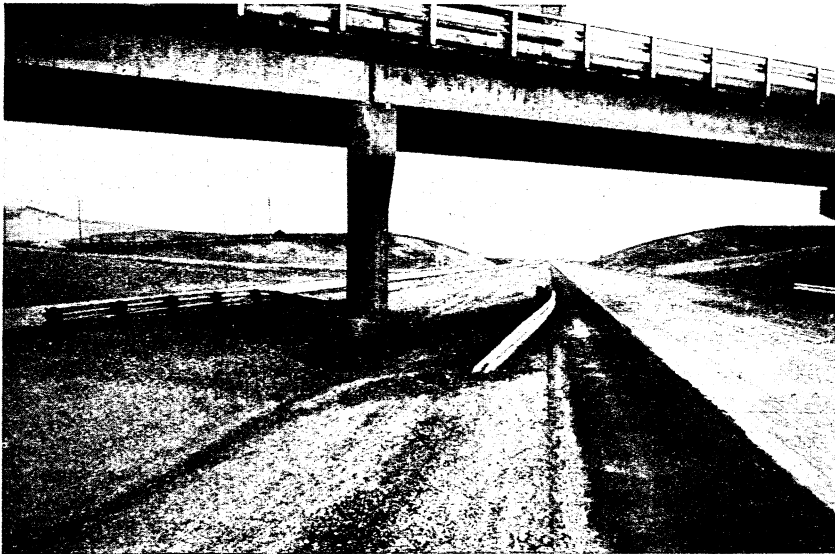
But here we swing around and take a look at the median pier problem, in terms of where that rail is placed. This shot, of course, was taken perhaps a couple of hundred feet away and it is not too difficult to visualize someone getting into the bottom of this bowling alley gutter here that the chairman referred to a little while ago, and ending up in difficulty with that pier.

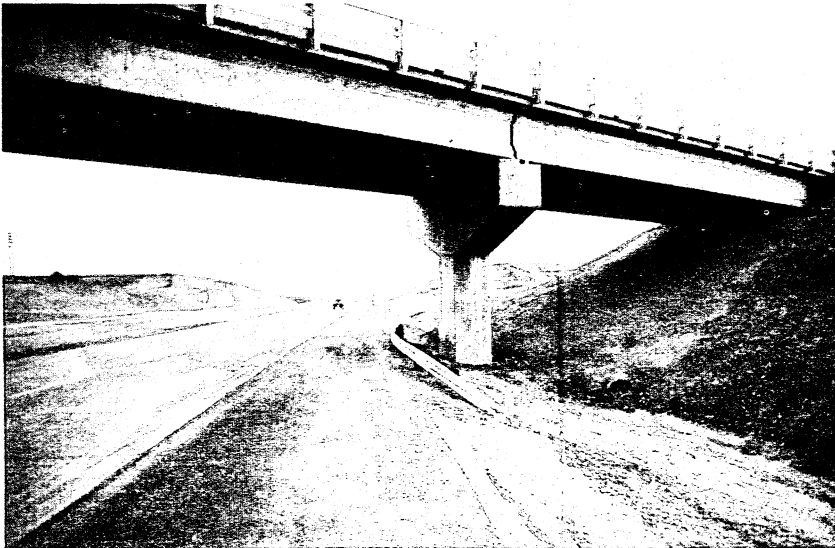
As you look to the right-hand side, you have about the same situation as a couple of hundred feet away. There is not an awful lot of protection here. You have a steep slope here which can turn you back
