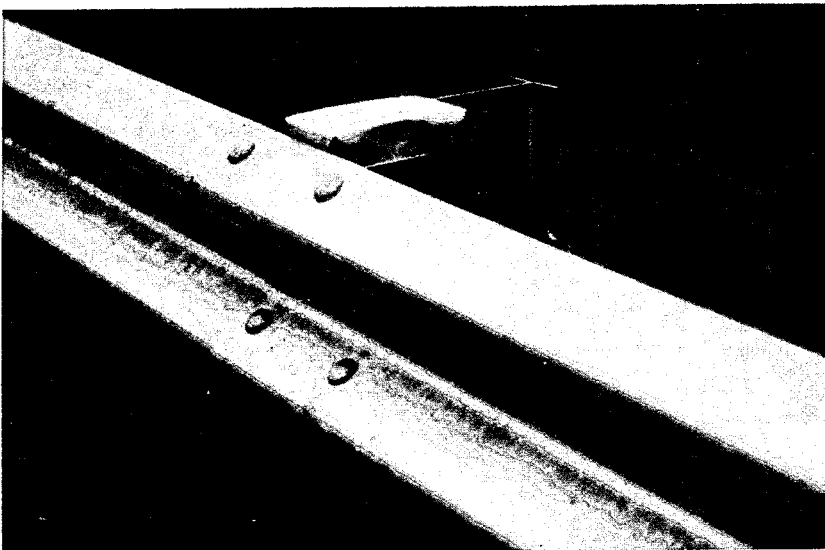
Here now is what you get as you get to a sign location.

You find that this block is produced. This is a 6- by 8-inch block fastened to a steel post, so that your rail actually is blocked out when you come to a sign location. This is only at sign locations.

Mr. CONSTANDY. That did not have a washer in it, Mr. Prisk?

Mr. PRISK. No. It did not.
