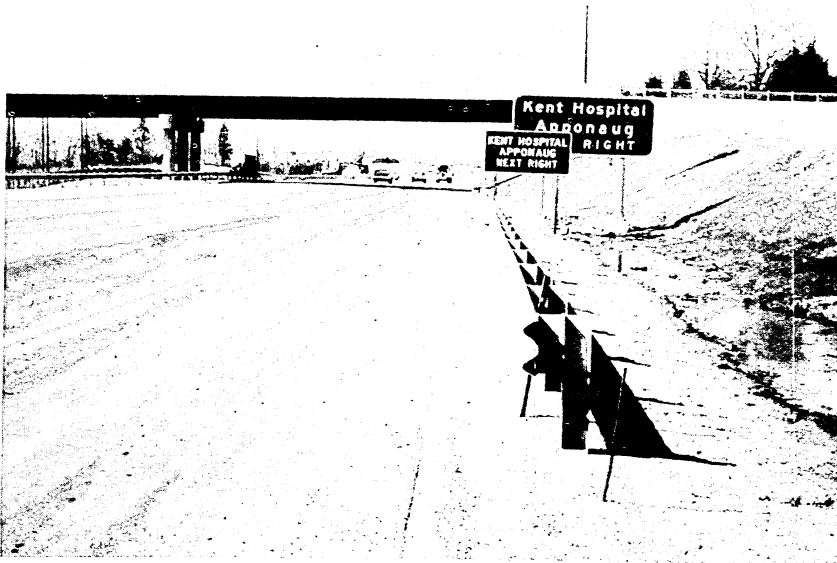
You also see several other things in here besides the boulders. There is the light pole, and of course the sign-support structure itself with its footing.

This job, as I said earlier, is not finished. You will see a couple of signs here that say the same thing, "Kent Hospital." Obviously the larger one is the final sign, which has just been installed; the other one just has not been taken down. Nor has the end of the guardrail been yet finished off. A good bit of the rail that we saw is exactly in this condition, exposed end.

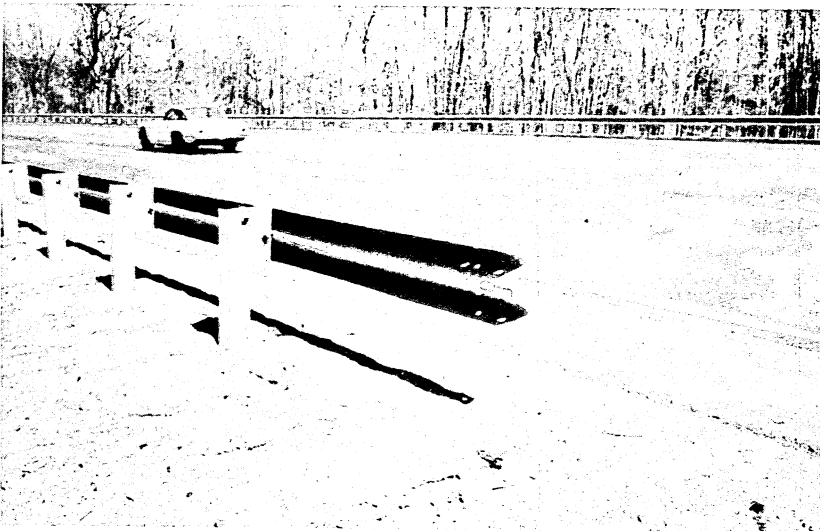
Here is more on the median side.
