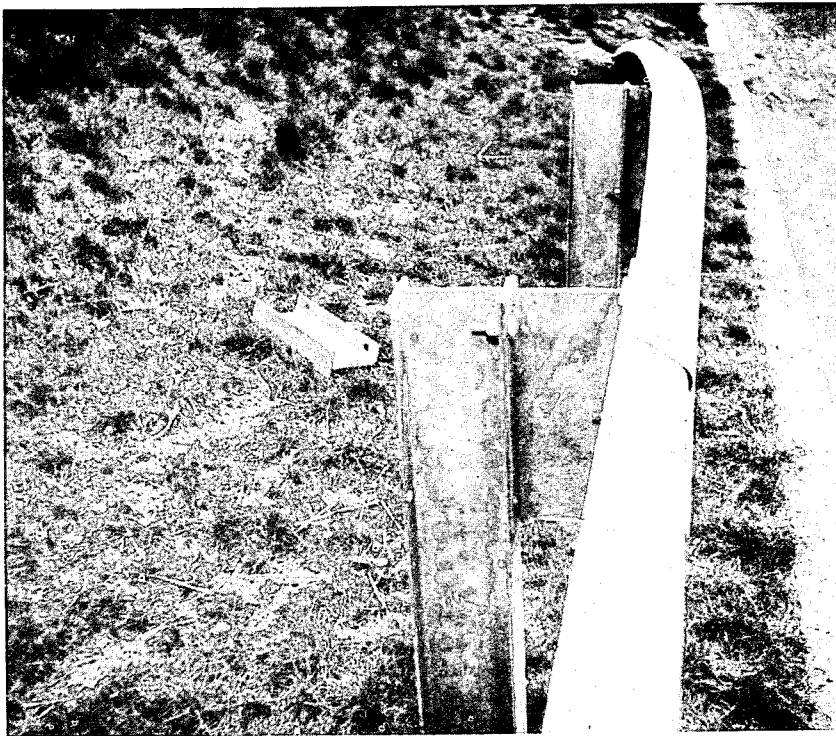
These are new designs. This is looking from the other direction. You see the steel blockout sections. These are just being installed. This does go directly into the ground.

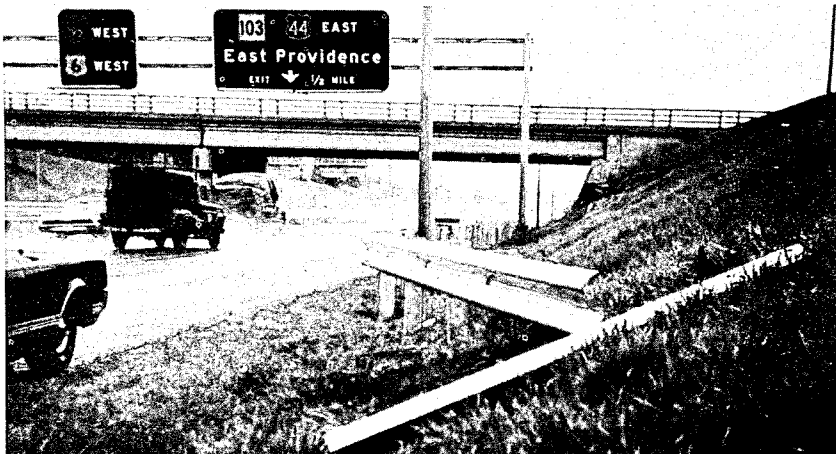
Here is the way it lines up when they take it back into an embankment. This section is not completed yet, but it will be anchored, actually anchored in the slope in this case.

This is all part of the approach protection for that structure you see in the distance.

This is north of Providence.
