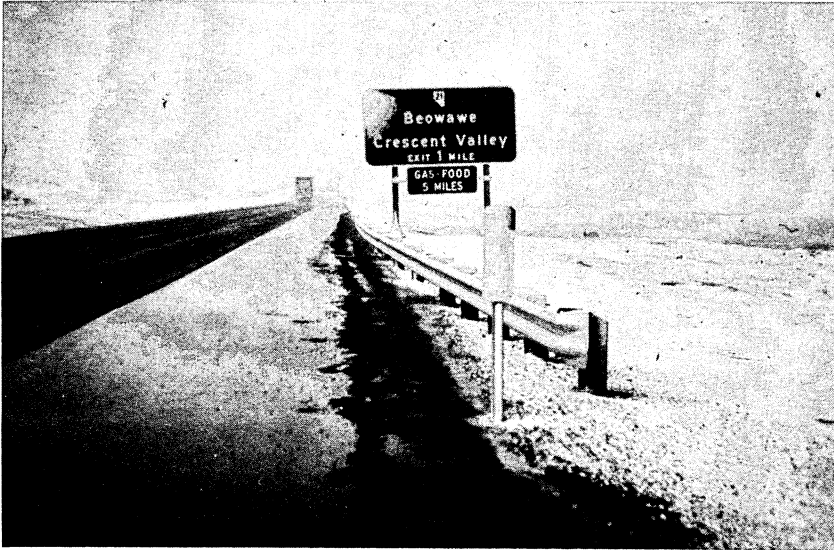
Going ahead, we see the advance sign coming in toward the interchange that I mentioned. We saw a closeup a little while ago.
