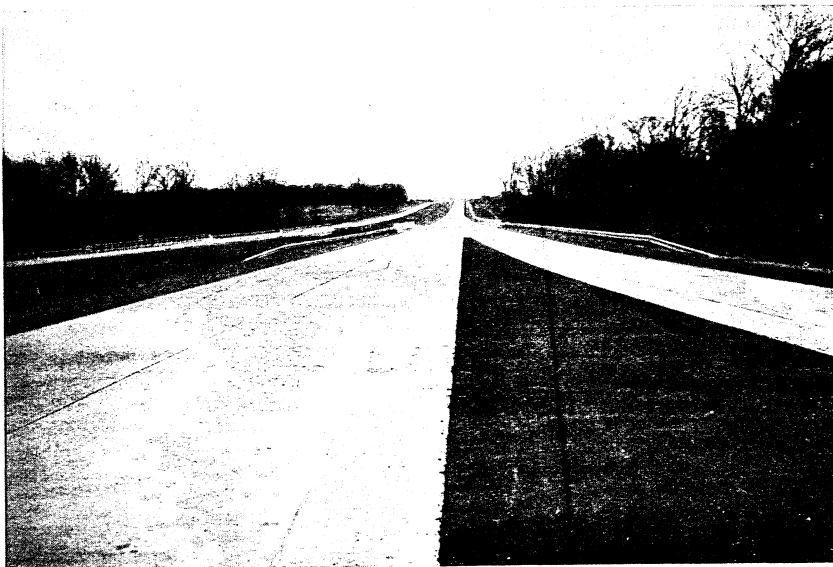
Now this is new work. We moved away from I-69, which is the route we were just looking at, and this is a portion of I-70, east of Indianapolis. And this is not yet even open to traffic. There is work still going on on it. So this is a brand new piece of work. And as you look at the first entrance ramp on the approach to a structure, this is what you see. The improvement has been made to lengthen the rails, both on the right and on the left, and the rails have been buried. The approach ends have been buried.
