I come back to still another job, and this is on the beltway around Indianapolis, where some work on guardrail and rehabilitation or improvement is underway. And this is the before condition.

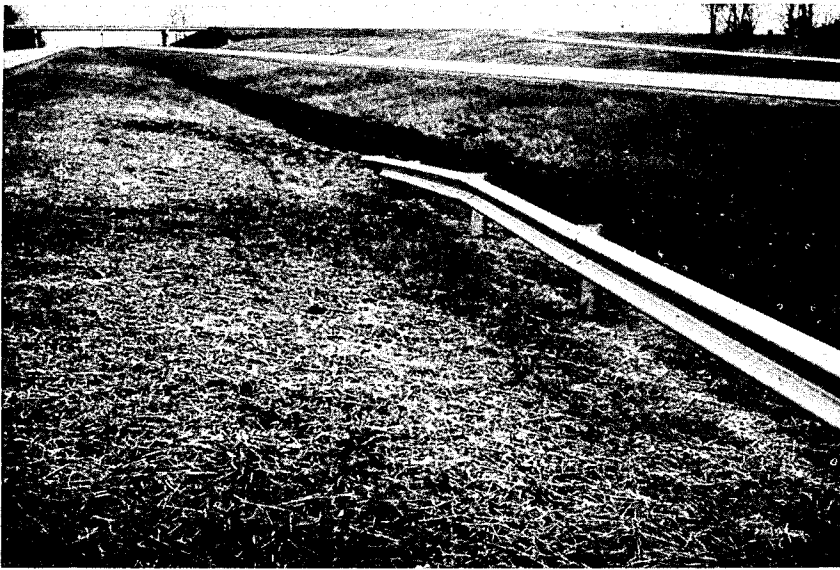
This is what the median end treatment looks like a little bit closer to it.

with a straight-up rail, to a section that now has a buried approach end at least.

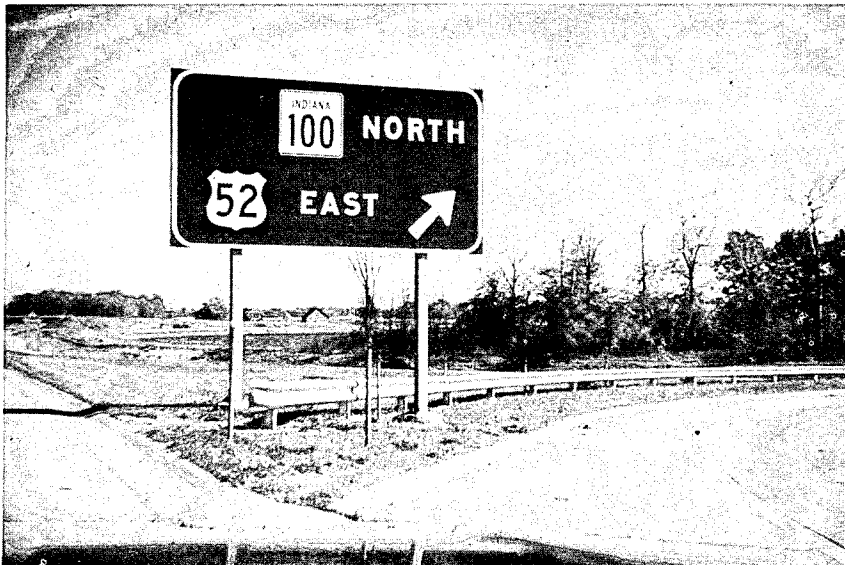
Mr. CONSTANDY. Before you get to the after, as flat as that area is beyond the guardrail, is the guardrail needed at all?
