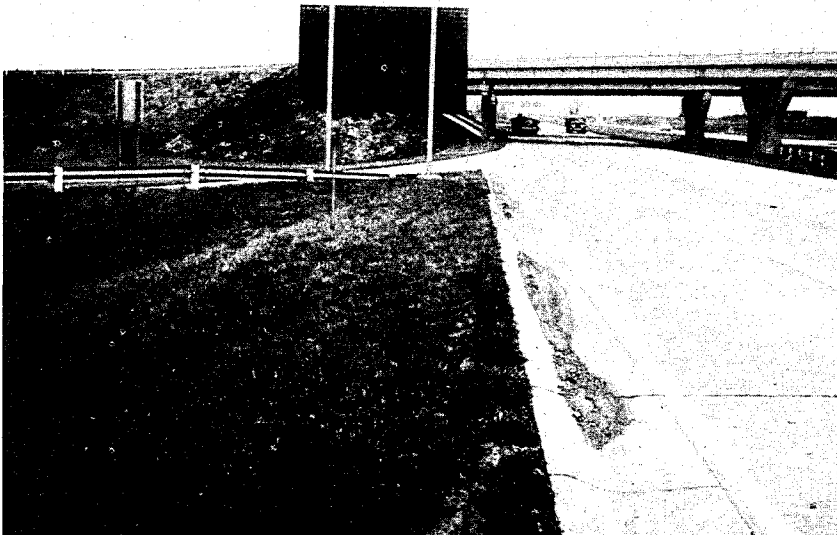
Mr. HUFF. With the apparent sharp angle of exit there, he had better take them out or somebody will take them out for him.

Mr. CONSTANDY. I am not sure of that. That is a formidable sign. It may be hit without much damage to the sign.

Mr. WILSON. Not really. As Mr. Skeels pointed out, and Mr. Huff as well, we are going to have to take steps everywhere to get these gore areas clean of all obstructions. And some of us are working in that regard.

The most that should be located in this area is breakaway posts, of some sort, supporting small exit signs. Everything else should be gone.

Mr. SKEELS. We have to get these signs out of these gores.

Mr. RICKER. This is the one some of us had proposed to change the text of the sign, so it did not need to be as large.

That is presently underway.
