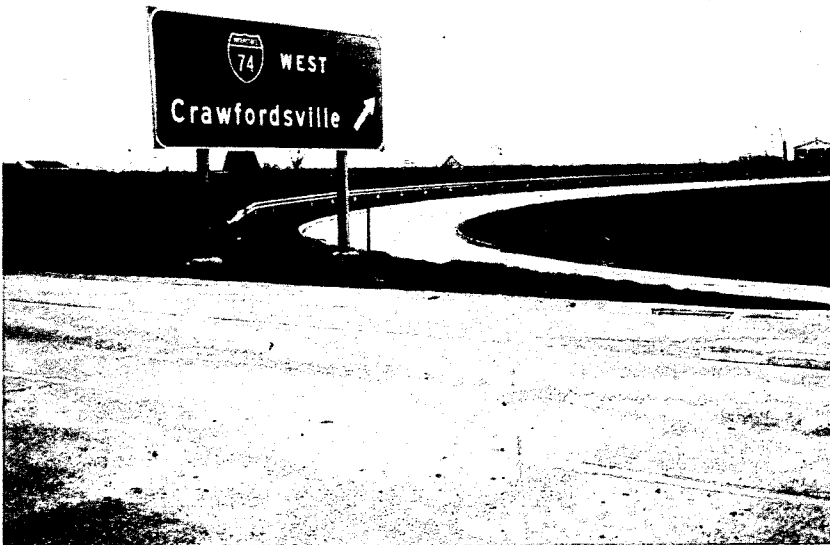
This is just to let you know it is not isolated. Here is another point where, again, you have guardrail coming down here. Not quite so close this time, perhaps, but nevertheless coming down, and it has been buried. You still have a fairly flat area out here. It makes you wonder why you need rail in here at all.

Mr. SKEELS. You might eliminate the guardrail in this. It does not appear to be necessary.

Mr. PRISK. So I think there are places where you can say safety is not costing money, but is actually saving money. This would be one place.
