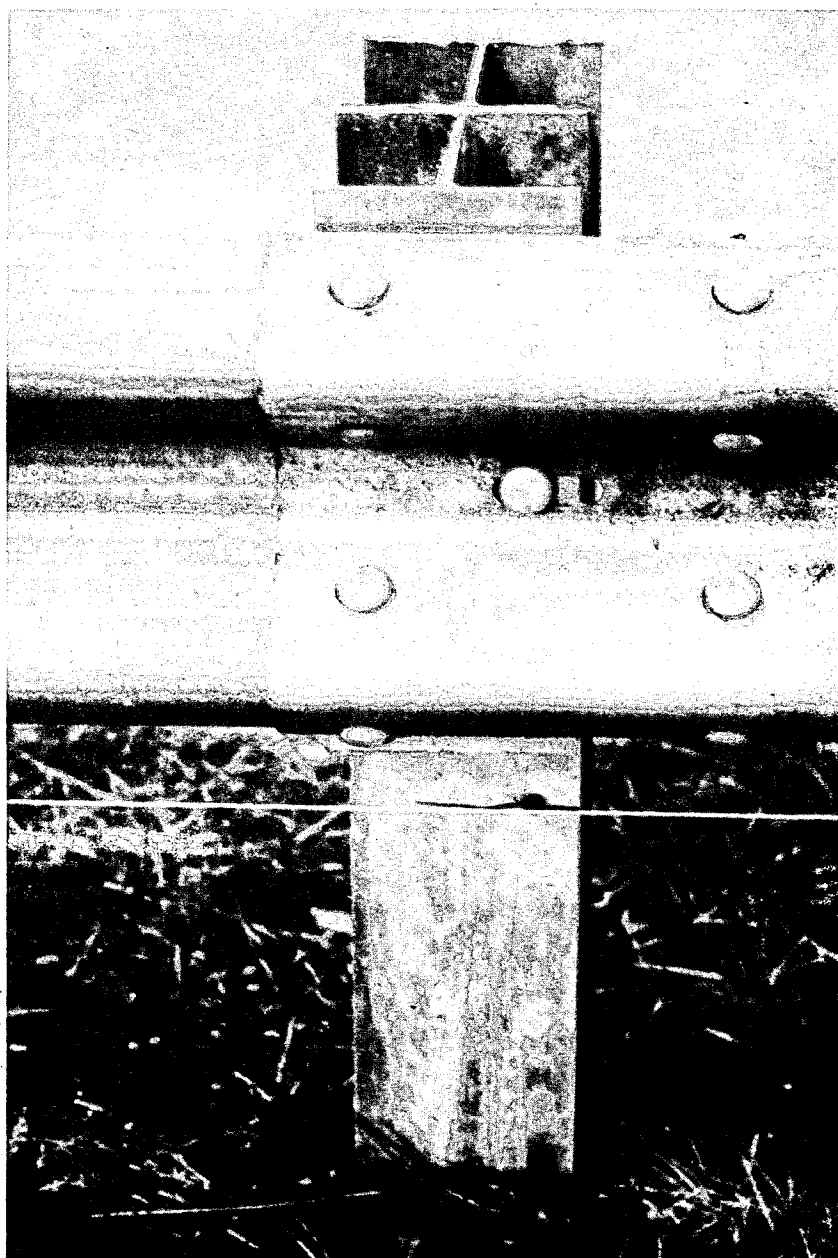
637

Now, this is one of the posts that is being erected underneath that undercrossing that you looked at a moment ago. The rail here again was up on top of a curb and it is, as you see, put in without washers. And it was none too high at this point.
