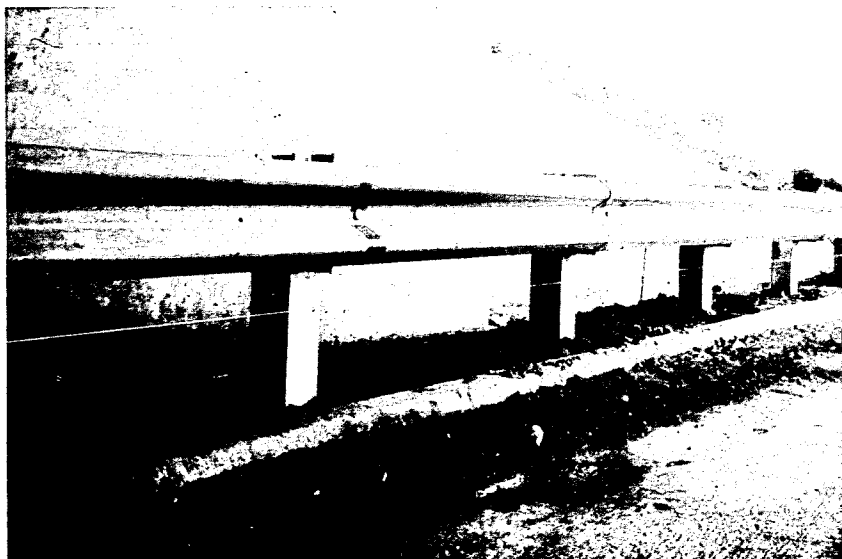
Here is the view along the rail showing the blocked-out section. That much was being done.

Mr. PRISK. No. That is just a string line; they were driving the posts while we were there and this just happened to be a completed section.

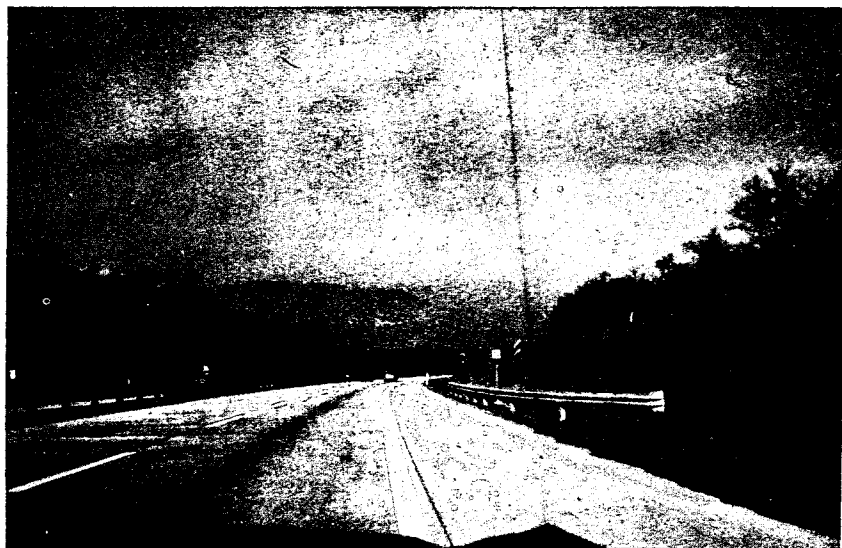
This is to show that other places are taking some account of what is happening in guardrail accidents. I put this slide in to show the committee that Switzerland has taken steps to improve their guardrail design. This is a view on the Lucerne-Geneva Expressway and shows that the guardrail is flared back and followed in to the embankment.
