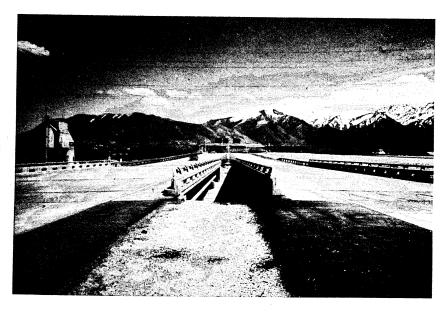
Here it is looked at from the other end, looking back. It is probably no more than 8 or 10 feet clearance at this end, at the most; perhaps as little as five or six at the other end.

Mr. Constand. Incidentally, that particular spot has the usual skid marks of vehicles in advance of the structure, but the area beyond is equally covered by skid marks from people who are yet undecided, after they pass the bridge, in which direction they want to go.

Beyond the structure it still is traversable for an appreciable area,

and it is used as a crossover in that situation.

Mr. Wilkes. Possibly. That would, of course, have taken out this rail and parapet entirely and made a paved section across the open area.

Safety would be considerably enchanced by the removal of those inside parapets and paving the space in between.

make the gore area as flat and as traversable as possible.
