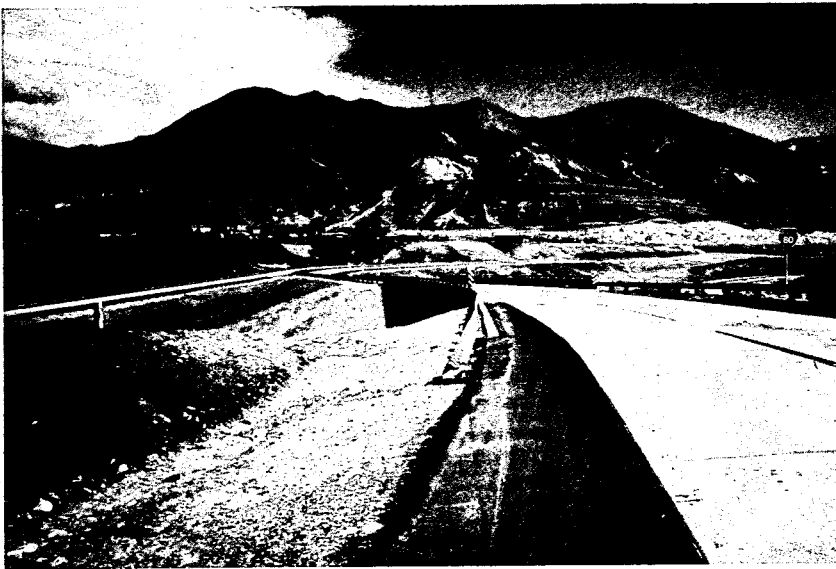
We have a picture here, now, of a structure where one of these was hit. This is a rail approaching on the left that I refer to.

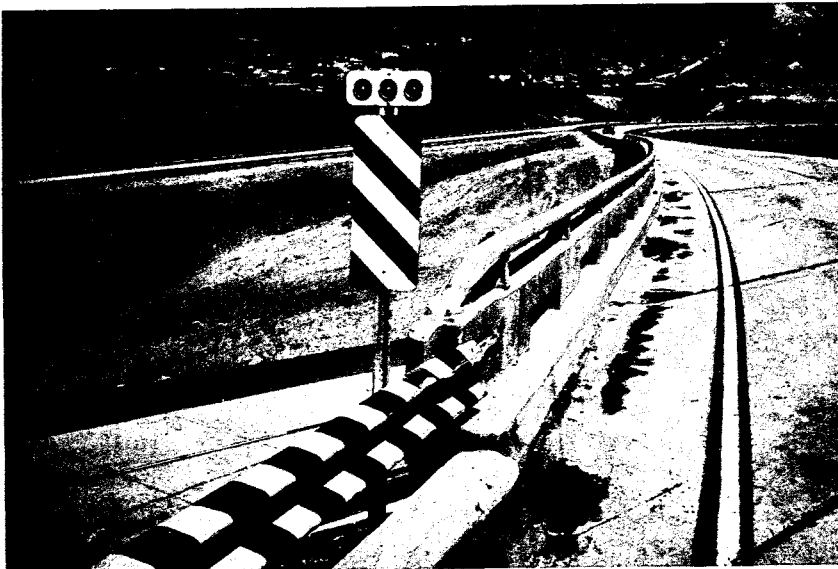
There is a closeup of the damage to the curb. Evidently a car topped this curb and got up into this area, and also did a little minor damage to the bridge rail itself; but it was getting up fairly high. We have no details of the accident.
