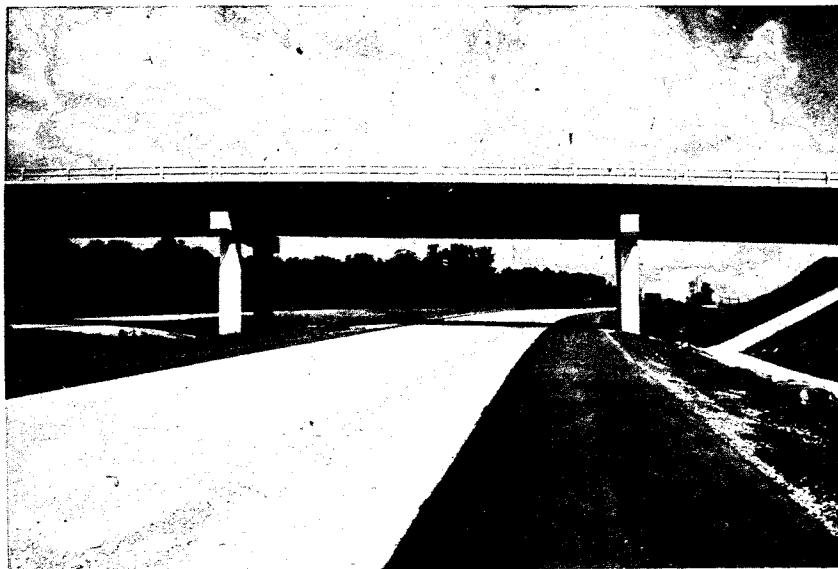
Mr. PRISK. Moving now to our next State, which is Georgia, we find undercrossing structures of this general type.

The side pier is in here, clearing the edge of pavement by 14 feet. There is no protection in terms of any rail installed here, nor is there on the center piers.
