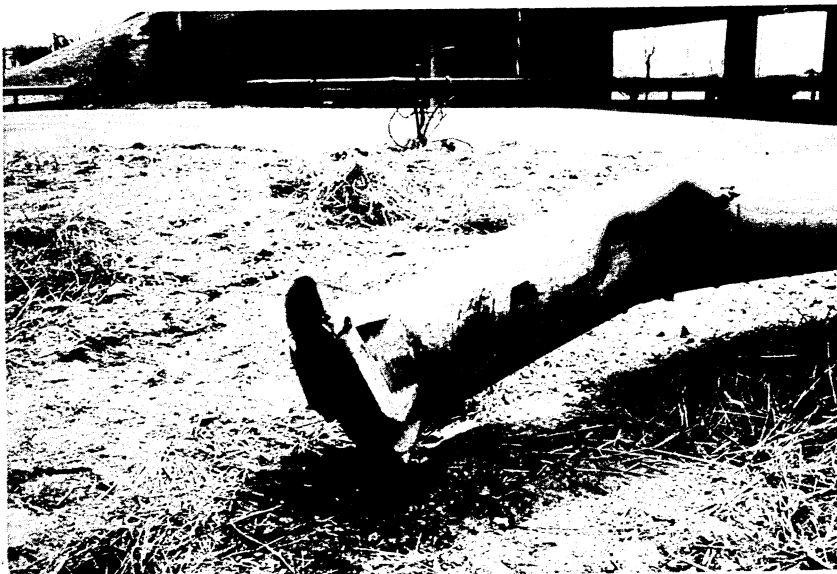
Here is a closeup of the pole after it was hit, presumably an impact about bumper height, as you can see. And the pole is broken away here at the base.
