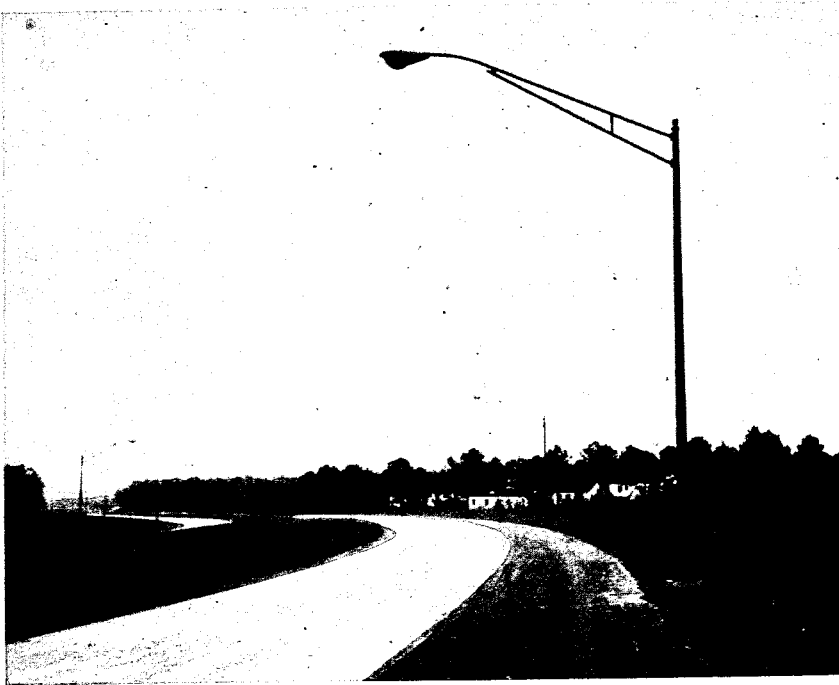
Here are some of the things that Mr. Wilson mentioned, the same narrow clearance to the edge of pavement, and 1 or 1½ feet, possibly 2 feet at the very most, showing off the edge of that pavement the unprotected posts or base.

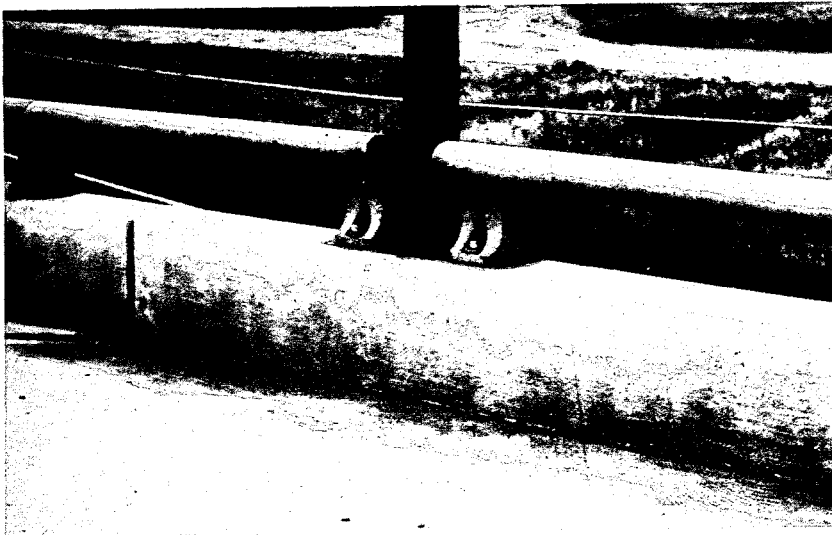
Here is one upon the parapet wall of the bridge which does afford the protection by the structure that is there.
