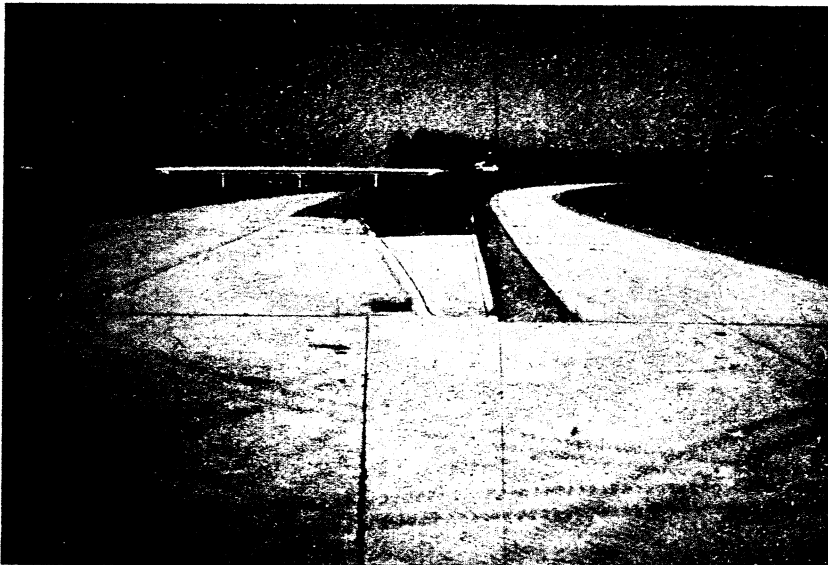
I am going to start with a fairly good location. I would say this is one of the best gores we saw. This is on Ohio Interstate 80-S. You see out here that the curbing that is introduced in the gore is extremely moderate, coming down to as little as an inch at this point, rising up here to perhaps 3 inches, and this distance from here back to here is about 30 feet, which does stand out as a target area for dividing traffic that would leave by this roadway or the through traffic that would go down here.

It just so happens this particular section right in here is not yet in use. The Interstate project includes this but is operative only from this structure away from the camera.

**Mr. RICKER.** Could I comment there? There have been suggestions that the exit sign be removed from the gore. I think this picture illustrates why it should not, particularly on the gore visibility condi-
