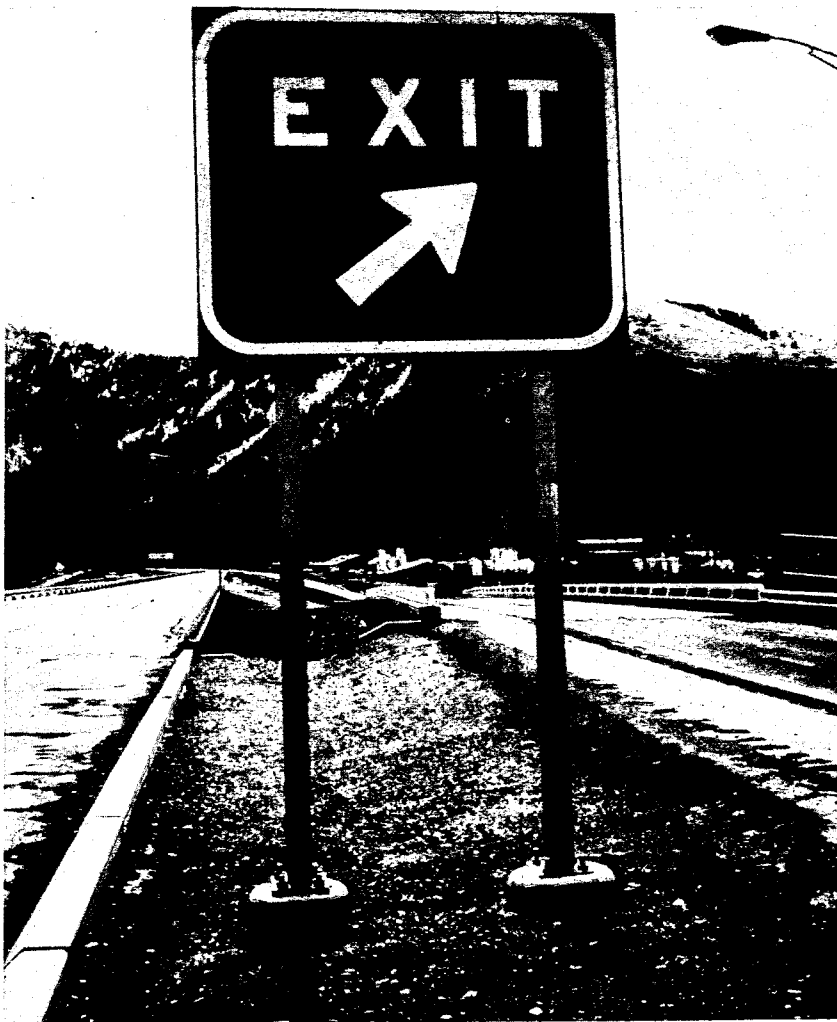
You have these two 6-inch I-beams on the exit sign. Following the practice in this State you also have the additional hazard of the hole between the bridges. This is in Montana, I should say.

Another gore with a non-break-away sign support, otherwise quite easily traversable up here for several hundred feet if you do run off.
