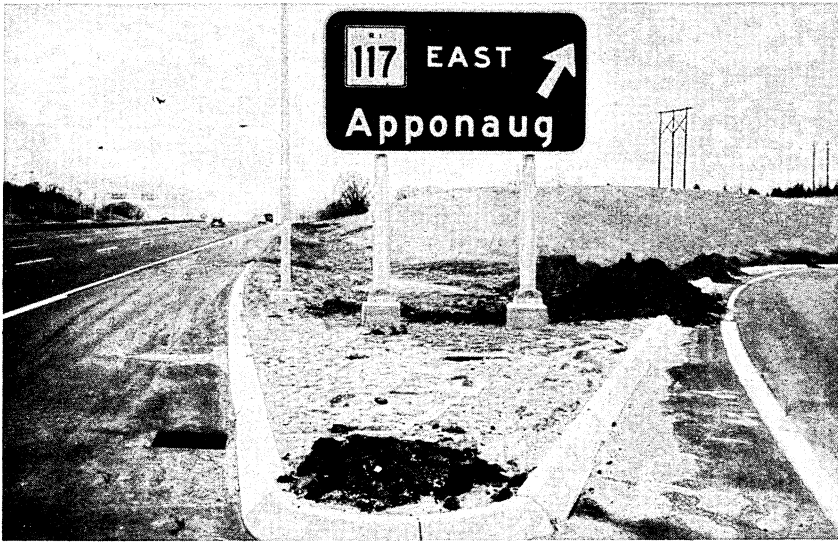
This is another gore situation which we saw where there is a curb here outlining the gore, and for the life of me I cannot see reasons for curbs in this kind of a situation.

The footings are high. These are concrete footings, these blocks you see, topped by aluminum poles, which will snap all right if you can get up to them. But possibly when the final grading is done here, as someone suggested this morning, this will be brought up to grade, so that you will not have anything except aluminum poles to contend with.

I think I still would feel a little more comfortable with a true break-away slip joint in there.

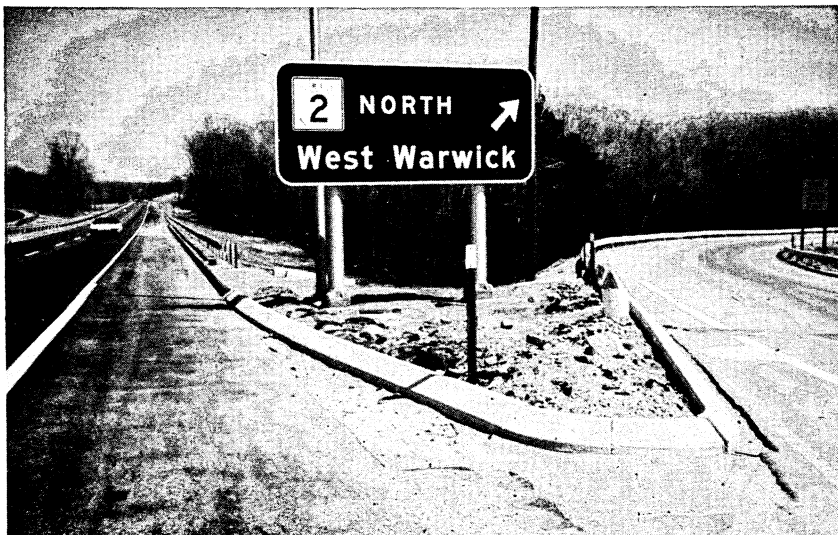
This is another view of a similar situation. We do have a guardrail difficultly in here. This job is still in the cleanup stage. But you can
