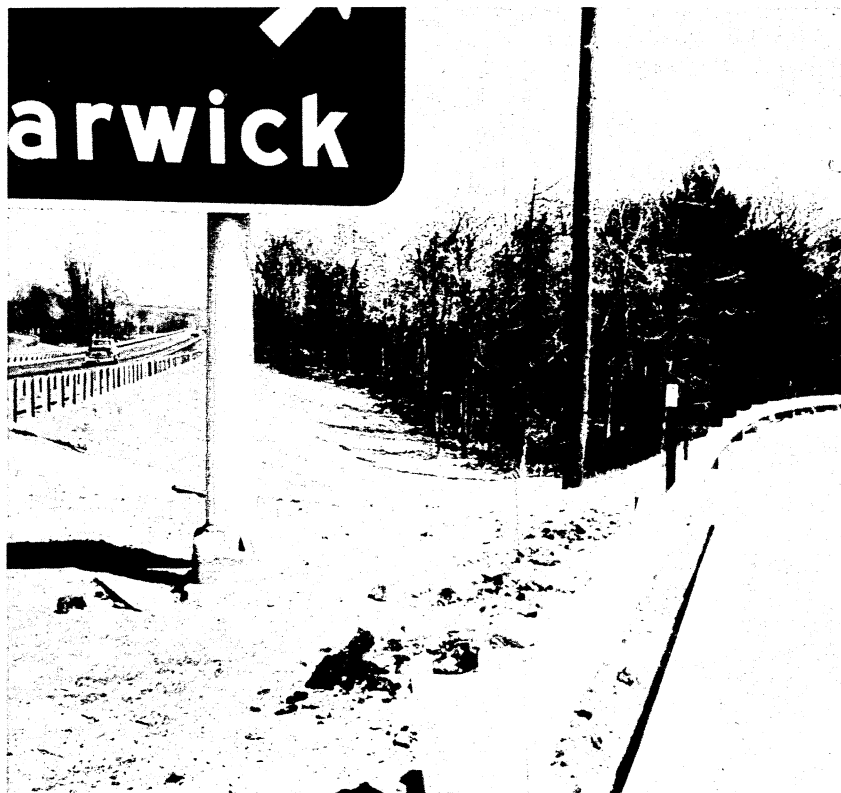
That previous shot (slide) this one here, of course, that will be filled to curb height, we expect, in front of the sign.

In back of the sign, shown by this next picture, I have no way of knowing if anything is going to be done there.

Mr. CONSTANDY. What I am wondering about, when that fill is added, in this particular one at least, it would seem that the concrete footings of the sign would then not project above the grade quite so much.

Mr. PRISK. I think that is true.

Mr. CONSTANDY. Before that project is completed, it is probable that there will be more fill put in that gore; is that correct?

Mr. PRISK. Right there at the beginning; yes.
