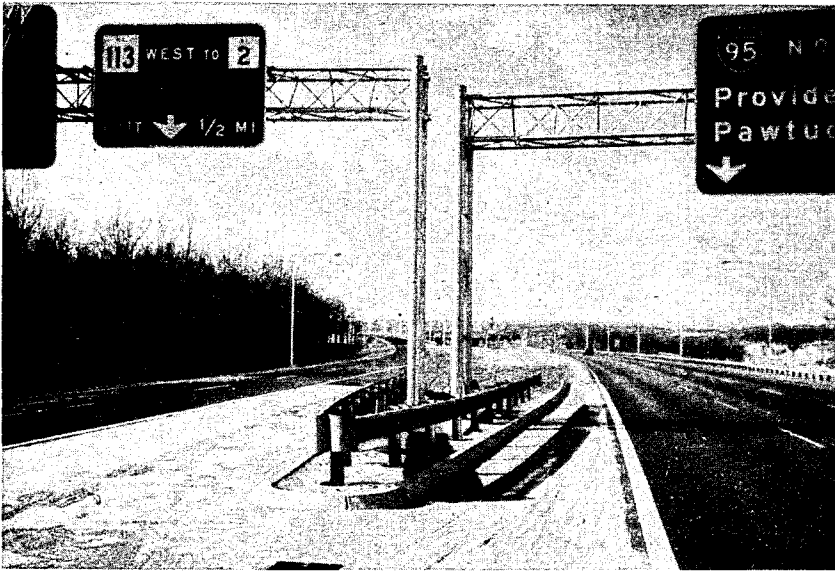
And here we have the gore that you saw as we were looking at signs in particular. This, again, could be relieved entirely by the plan that is now in mind, which is to replace these two structures, both of them having center supports in the gore, with the single structure moved back toward the camera a couple hundred feet.

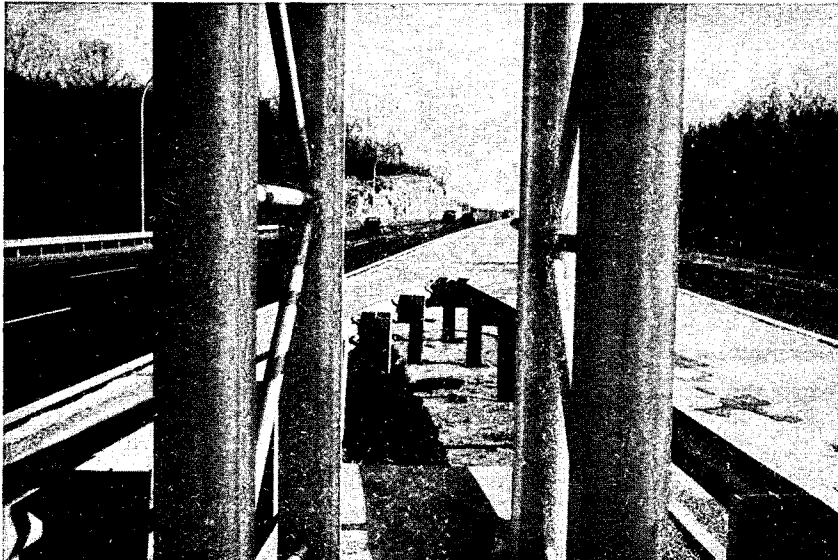
This is a pretty formidable thing to run into.
