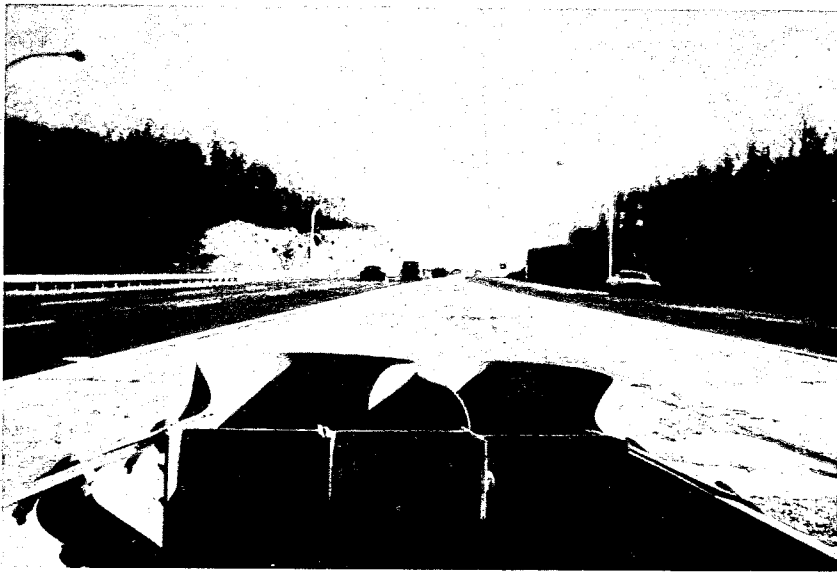
That shows the long wedge of white concrete coming on up to that gore and does provide very good visual delineation between two roadways. That is an excellent feature, one that needs to be commended as much as the signs can be condemned.

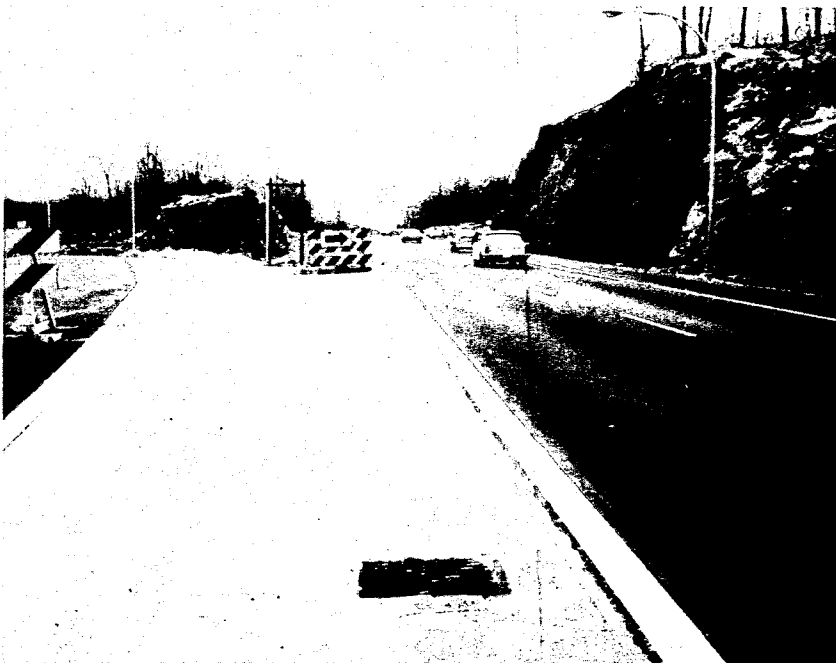
There is another use of concrete wedge between two asphalt pavements. This is a rather rough gore, if you move on into it, because this is rock in here and, of course, rock in the vicinity in general.
