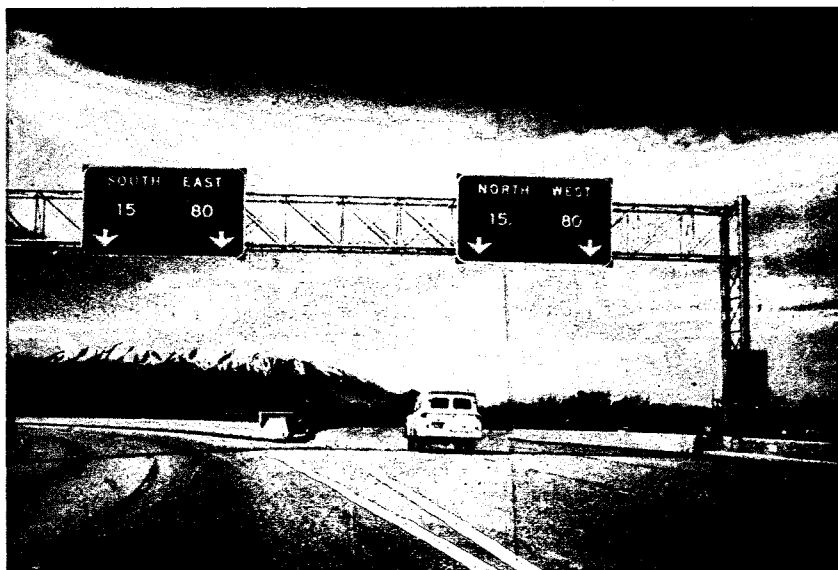
This gore in Salt Lake City is the kind of situation that also is met in some urban areas where walls exist. This is the prow design. I think someone mentioned this a day or so ago. This is shaped like the hull of a ship almost, upside down, and laid up here, and gradually increasing slope—little block of concrete that will stop you if you do not stop on that slope. Some of these work reasonably well. Under high speed they are not too effective.

The thing I would point out here, too, is the relationship to this system's concept that I mentioned earlier. You have South 15, East 80; North 15, and West 80. I do not know how that strikes most non-Utah residents, but it is a little difficult sometimes for drivers to distinguish between South 15 and North 15 when they are separated like this.

This is in here principally to show you the gore problem and, as I say, when you are in an elevated section or up on a high embankment, these rails and walls cause serious difficulties in the gore.

I have been puzzling over an alternate possibility. I think there probably are other solutions to that problem, but that is a signing problem.
