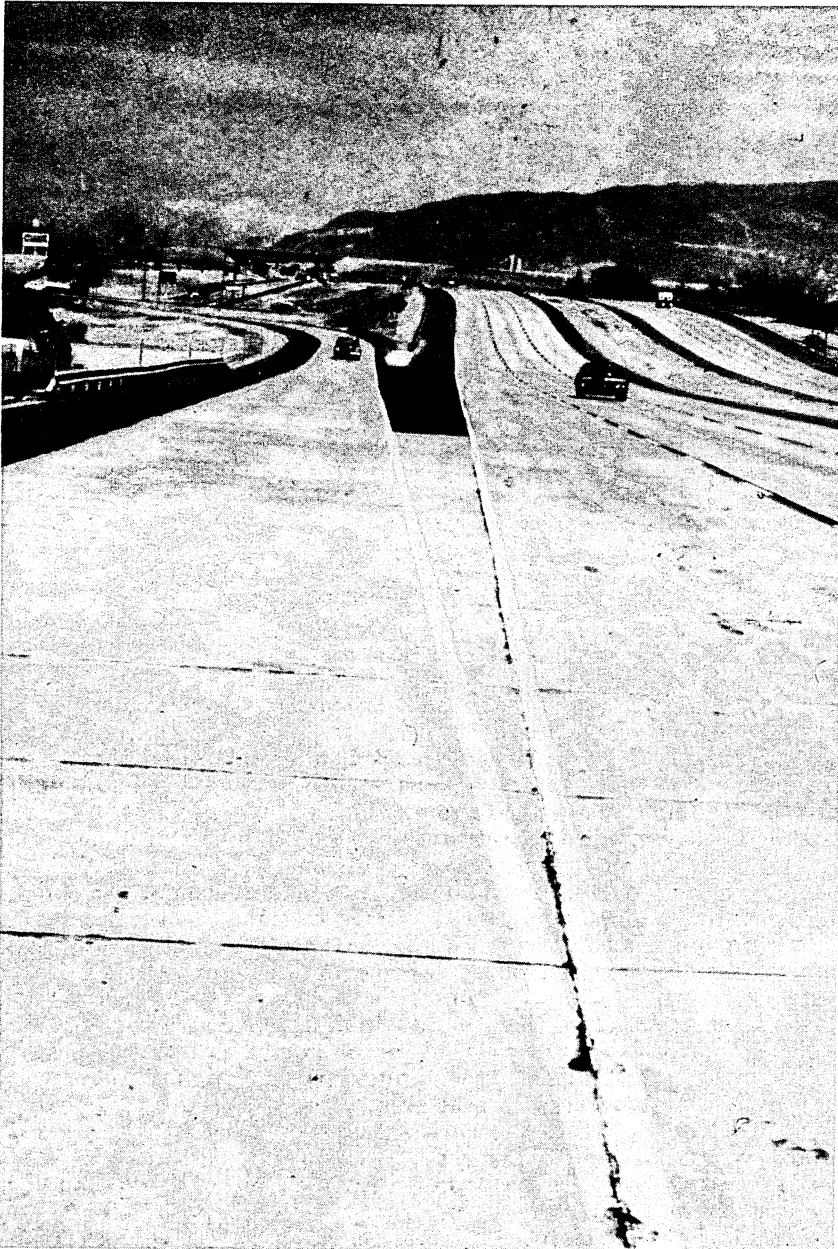
And here is another entrance gore showing how flat this angle really is where the roadways are brought on.  
This is on a section of I-15.
