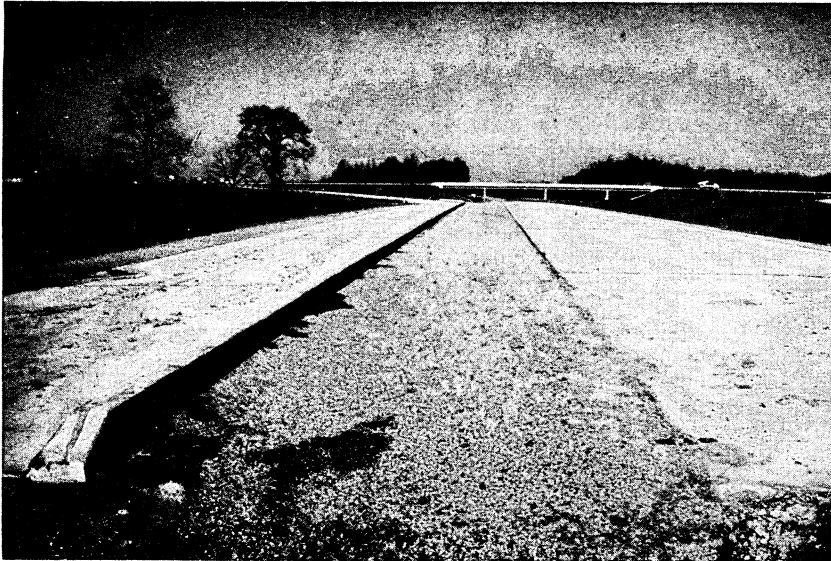
This is the use of curb in a similar fashion on another entrance ramp, on the same project, on a section not yet open. This is the end near where it joins the through lane.

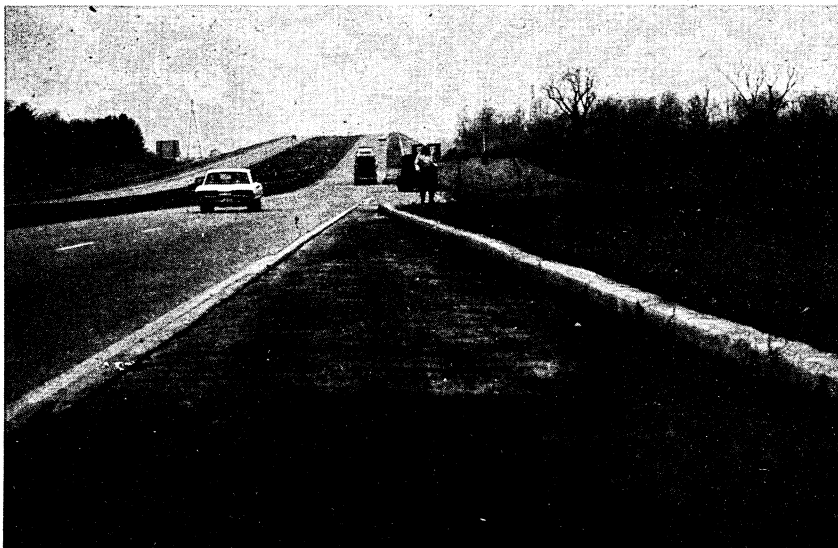
And this is a similar or additional type of curb situation. This is in Indiana where cars are unable, as they approach the entrance ramp, to have use of the full shoulder. You see the shoulder continuing up
