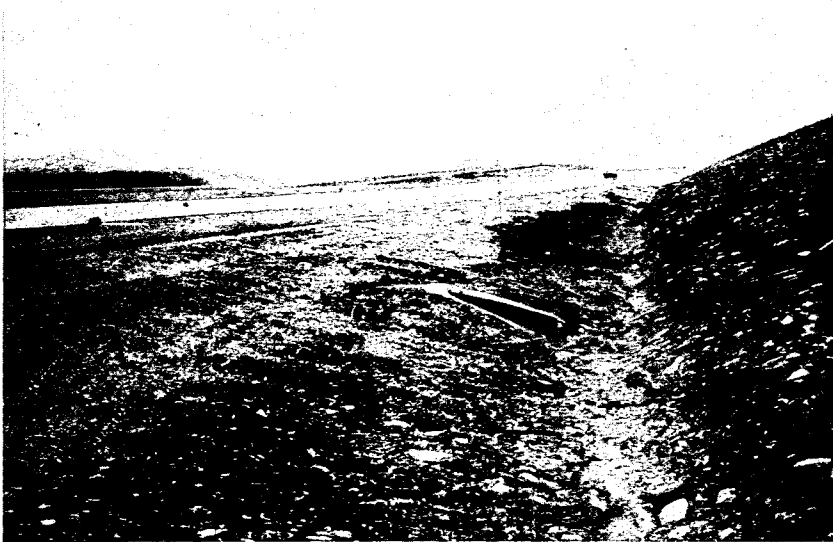
Also in Montana, we find this desirable cutoff culvert, which fits in with the slope profile.

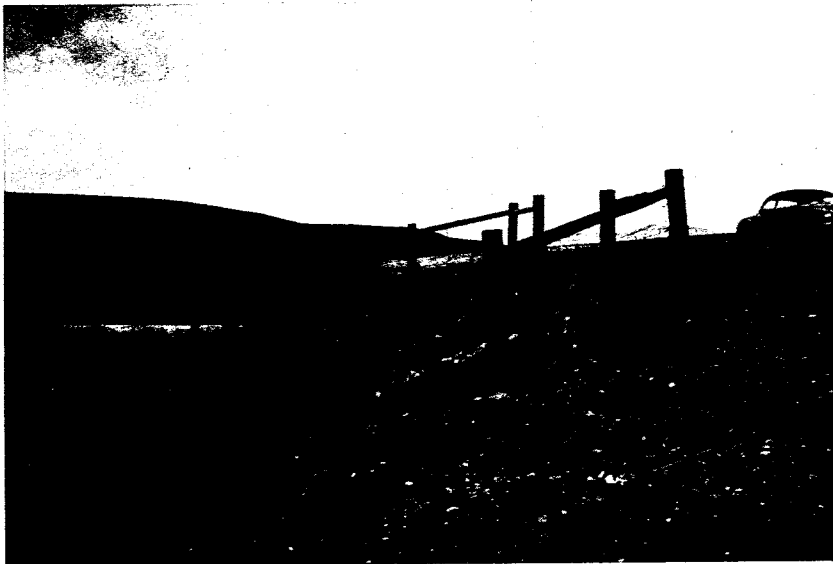
Here is another view of a drainage pipe extending out the side, also in Montana, where there is some hazard involved. It's very close to the roadway.

Mr. CONSTANDY. If that pipe had been extended, could not the slope have been brought back farther and that hazard been removed?

Mr. PRISK. It could have been; yes, sir.
