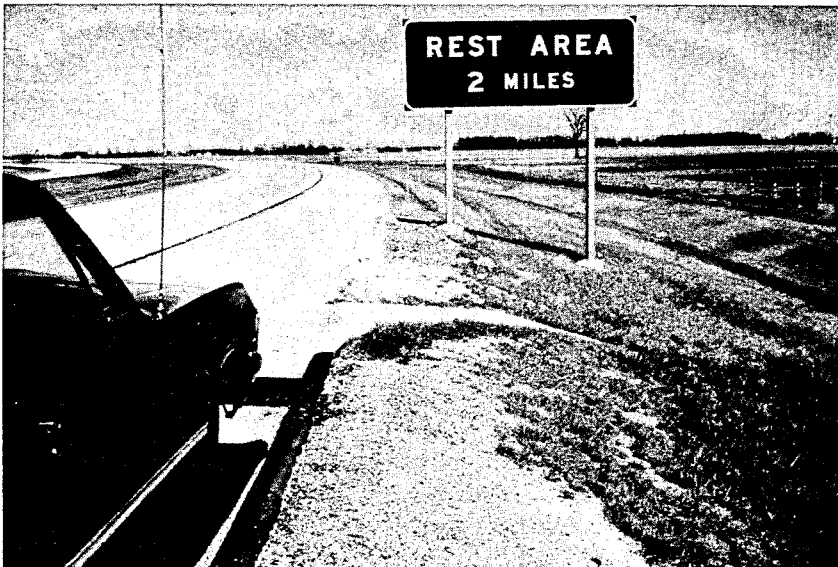
And here is an interesting drainage condition, also found on that project, where there is a ditch paved down the slope which, of course, is not unnatural, but up at the top there is a drop inlet at the same point, which [slide] going back to the previous slide for a moment, the outlet is at this point [slide] so you have two places for water to go immediately in front of that automobile.

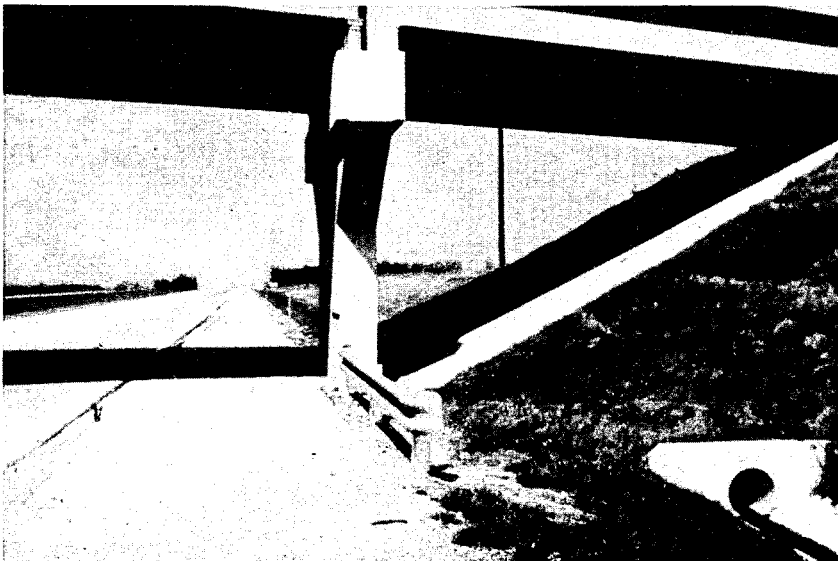
Very flat territory. This is also on the Indiana project, showing how they carry their drainage through the embankment behind the side piers. This is rather typical of many jobs that we were touring.
