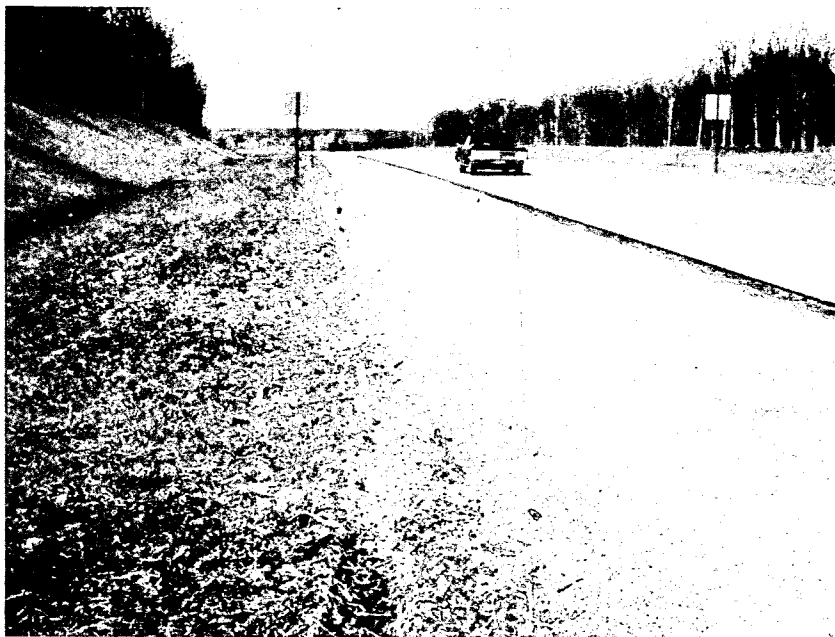
Off to the side you have nicely sloping roadside to backslope, made up here about 4 to 1, which can be traversed by a vehicle safely.

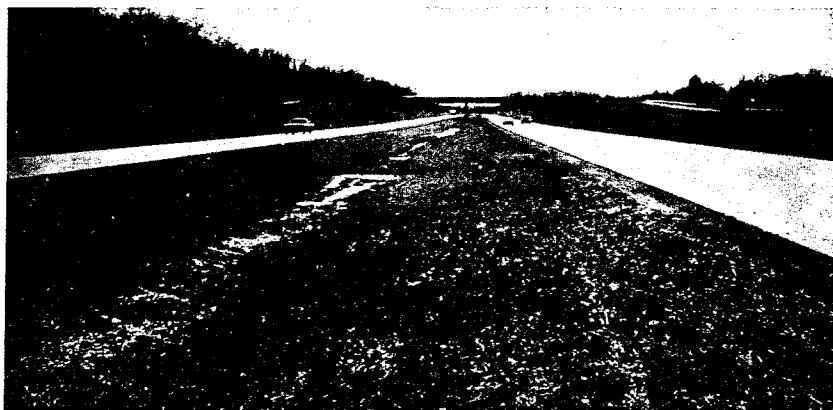
This is the median condition at this point.

Mr. CONSTANDY. This is on the other design section. There is an obvious difference between two parts of the section that we looked at; one project had this type of swale and the other one had the berm.

Mr. PRISK. That is right. This is depressed median and also somewhat narrow.
