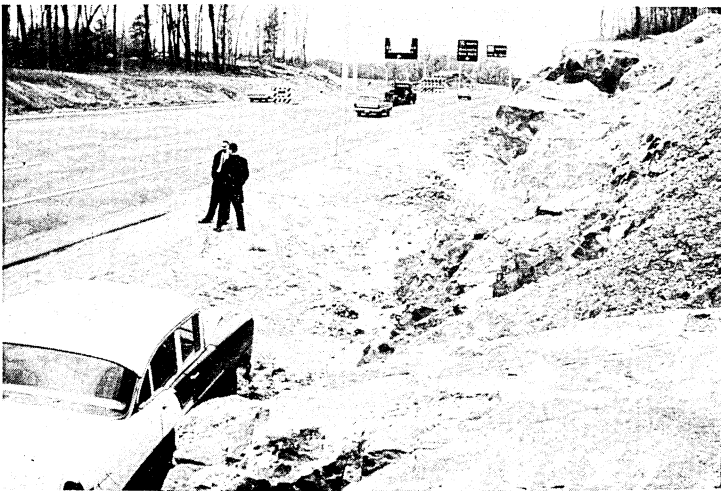
Here there is rock adjoining the roadside, and these slopes really ought to have some protection. It is hard to imagine how this can go on without ultimately proving to be a hazard. [Slide.] Here too is more of the same rock. [Slide.] Still more. [Slide.] And still more. There was an accident in this general vicinity.

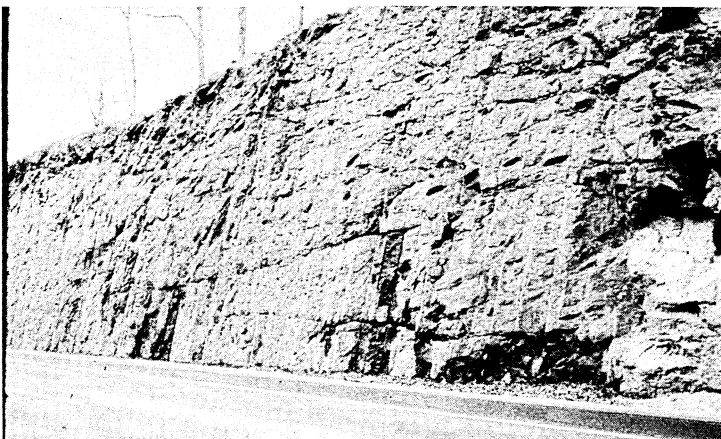
And here is a case where they cut the rock back in a slope plane, which leaves the rock with a relatively smooth surface as against the natural rock that we find in other places.
