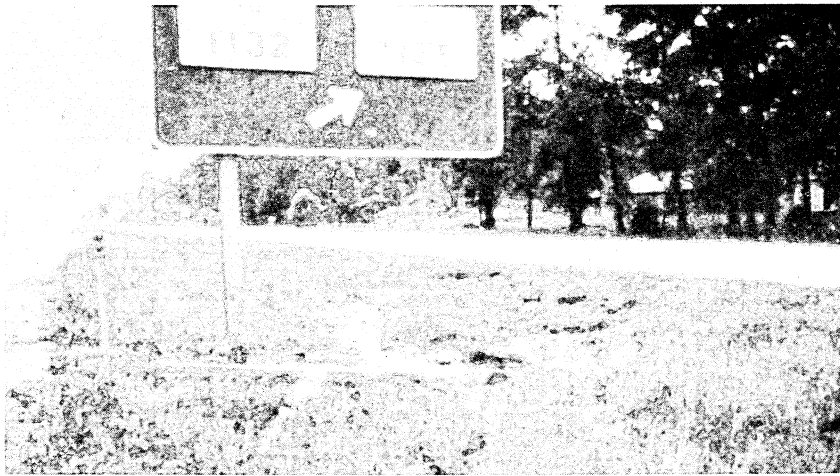
This is a sign that was impacted in a hit-and-run accident. You will note that the angle of departure from the roadway to the sign caused it to strike the outside leg of the support.

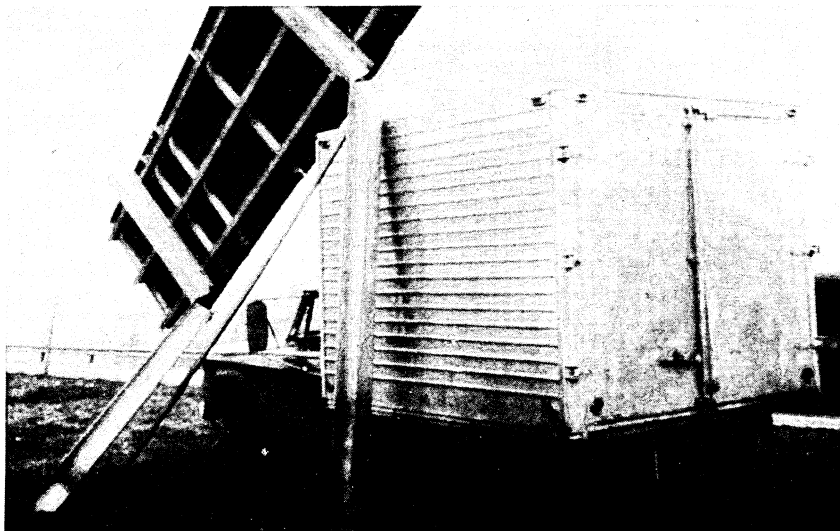
This is an accident showing the inside leg of the support struck by a truck. This particular driver went to sleep. There were no injuries or injury, type C. This was "no visible sign of injury," but there was complaint of pain. One hundred and fifty dollars' damage to the truck, \$125 damage to the sign.
