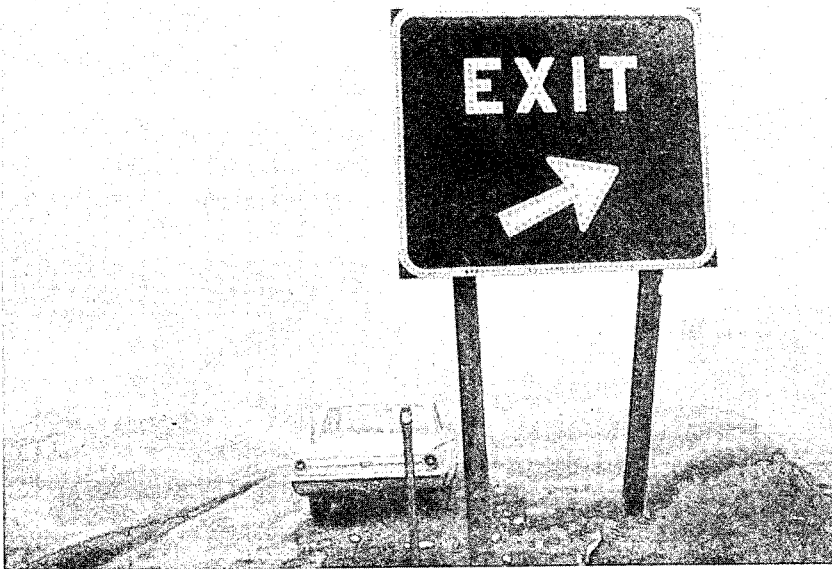
Here is another where the sign was struck at a 29° angle.

One item of interest might be that in accident No. 45, the vehicle struck the right support of a heavy roadside sign similar to this one, at 70 miles an hour, proceeded up an embankment, and diagonally across the frontage road, through a ditch, and through a fence, striking and shearing two braced corner posts 8 to 10 inches in diameter. The sign was hit at 8:45 p.m., repaired by noon.
