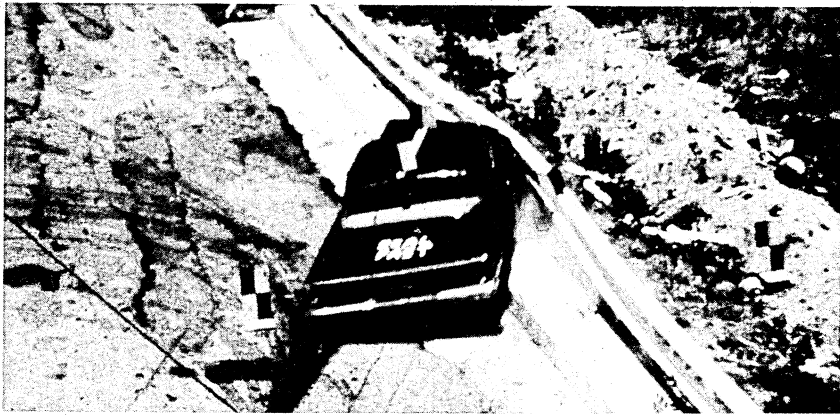
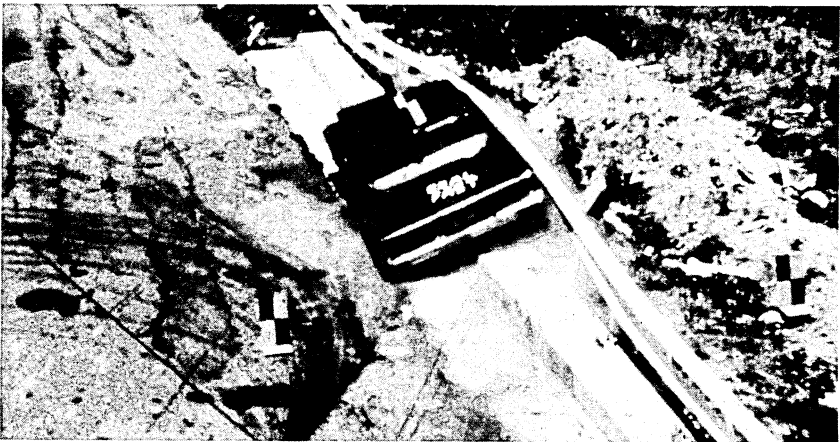
These sequences show an early test of the box beam bridge rail. This school bus, loaded with sand bags and weighing 14,000 pounds, hit the barrier at thirty miles an hour and twenty degrees. Redirection was excellent, and peak
