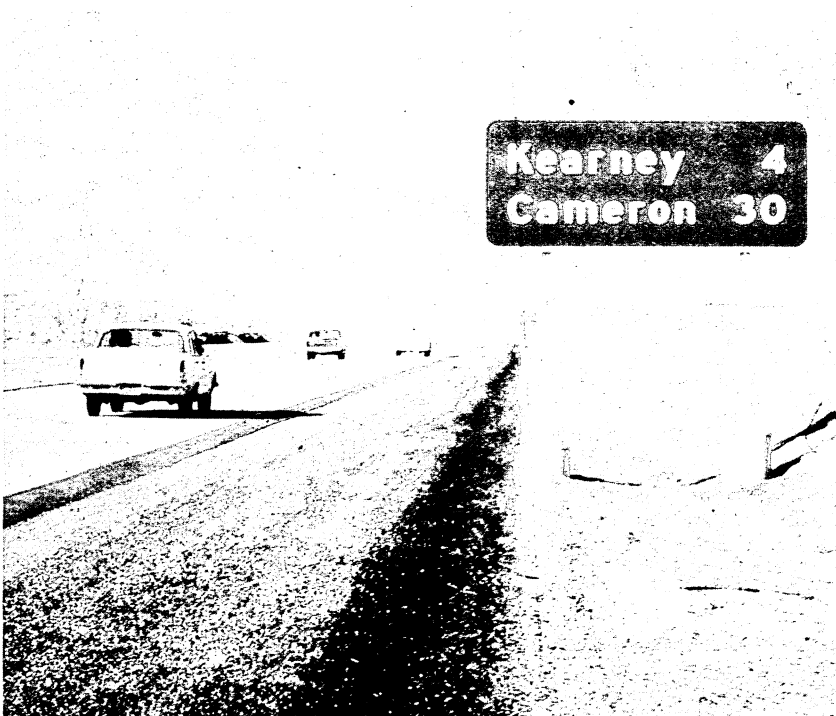
Here is a sign that is not untypical of the nine projects we visited. The right-hand leg is mounted on a concrete pedestal standing over 2 feet high. The sign support is 6-inch steel I-beams. It is 2 feet off the shoulder, the edge of the sign. The sign is otherwise unprotected.

You will note the message suggests that particular sign did not have to be located precisely at this point anyhow.
