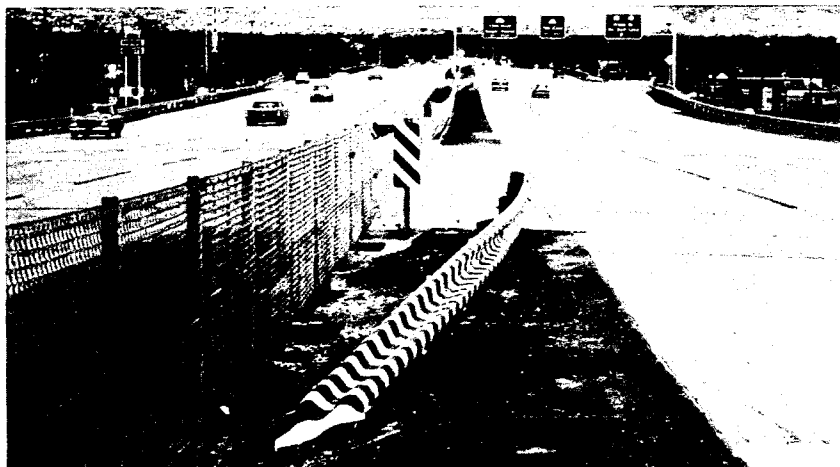
Mr. W. MAY. Again they have installed one, two, three different types of barriers because of this median, because of this construction of the bridge.

Mr. W. MAY. I am sure. That represents real hazardous location the way it exists.

Perhaps they could level that concrete parapet or median barrier and carry the cable barrier through the structure and remove this small piece of guardrail we see in the right. Again, the Bureau would participate in this?

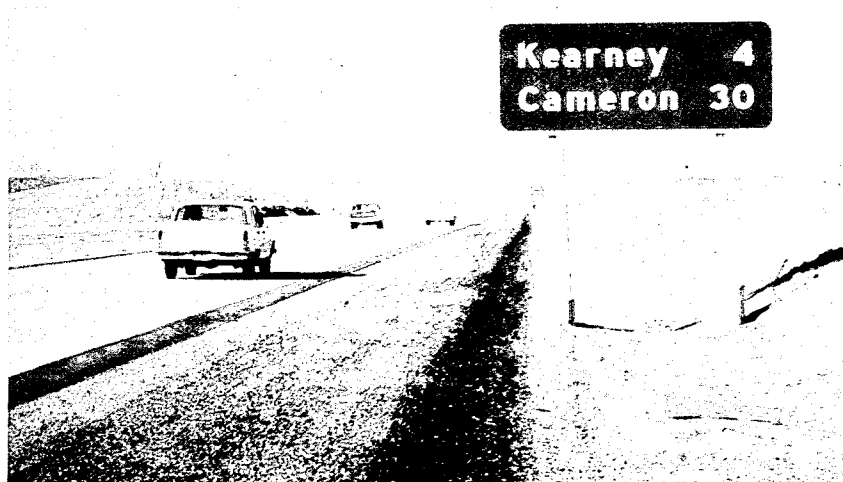
Mr. W. MAY. This is a typical sign installation right along the shoulder. Again, if that sign were to be moved elsewhere, the Bureau would participate?
